Engineering Geology and Landslide Hazard in Taiwan

Meei-Ling Lin
Department of Civil Engineering
National Taiwan University

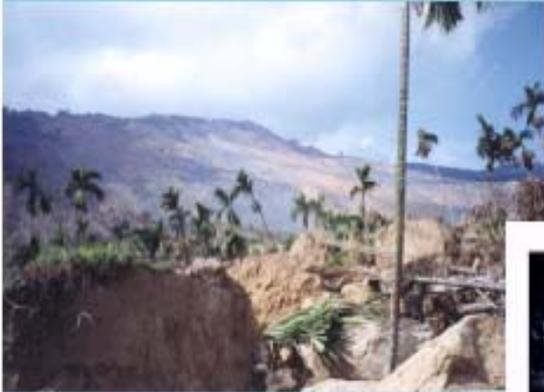
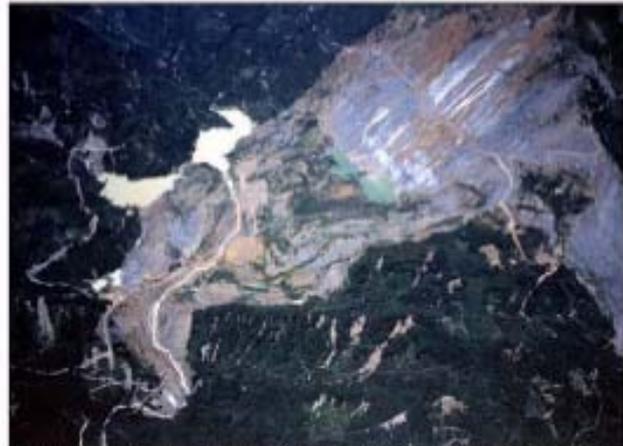
Chiufenershan Landslide

- ◆ Sliding area: 195 hectare
- ◆ Debris volume: 40,000,000 cubic meter
- ◆ 39 people killed

Bird's eye view of Juo-Feng-En-Shan on 24th June 2000 (Courtesy of Mr. Lien, Yung-Wang)

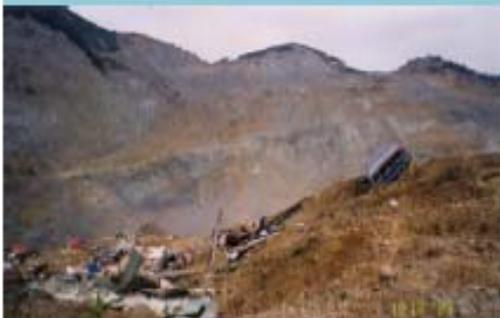
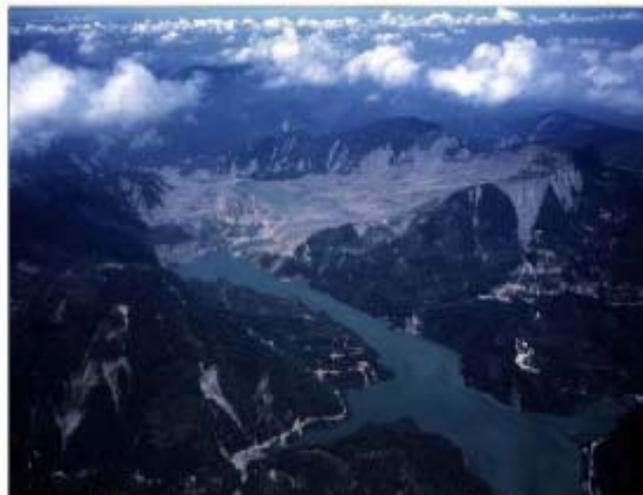
Tsao-Ling Landslide

- ◆ Sliding area: 400 hectare
- ◆ Block length: 5km (upstream to downstream)
- ◆ Debris volume: 120,000,000 cubic meter
- ◆ 29 people killed

Figure Bird's eye view of Dam-up lake, Tsao-Ling village, and the landslide area, looking to the north-west direction. (Photo taken on 29th June 2000 by Mr. Lien, Yung-Wan)

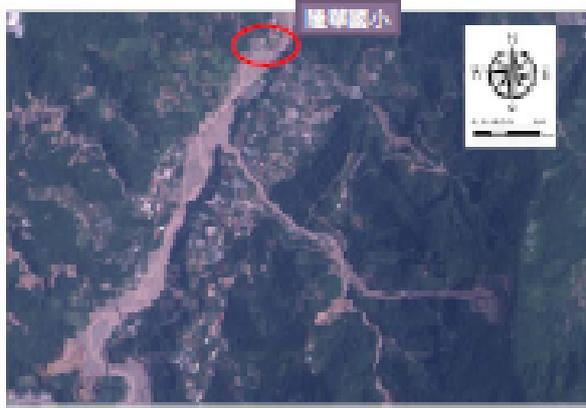
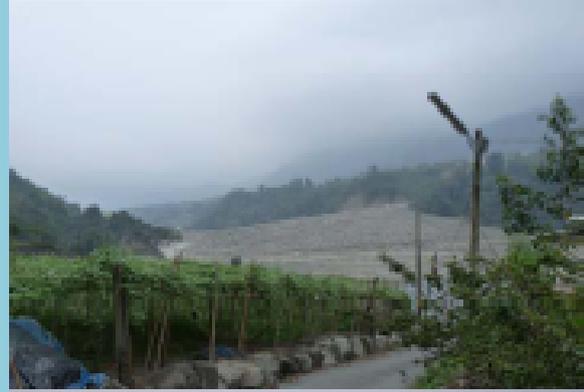
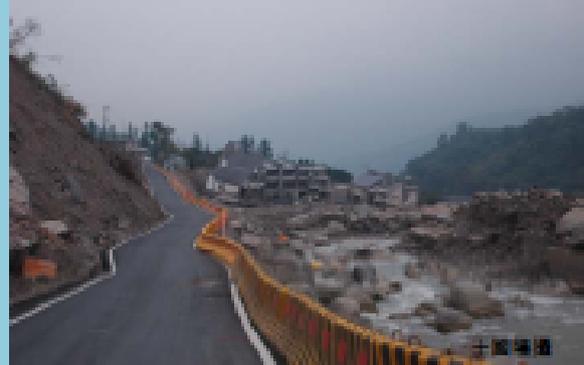
Tou-kern stream debris flow

- River channel pushed away causing bank scouring
- Lung-hua elementary school
- Tai 21 highway
