Rajamangala University of Technology Lanna (RMUTL), THAILAND

**2012 International Training Workshop
for Natural Disaster Reduction**

Major disaster in Northern Thailand

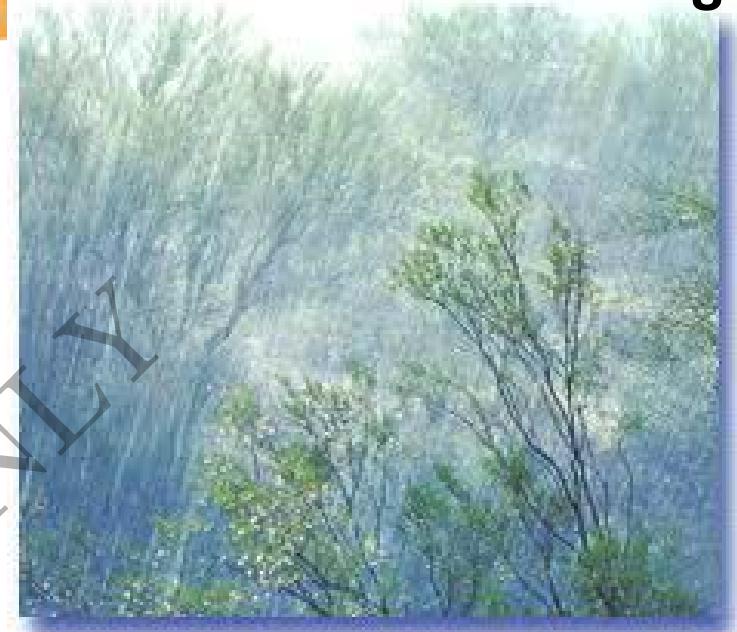
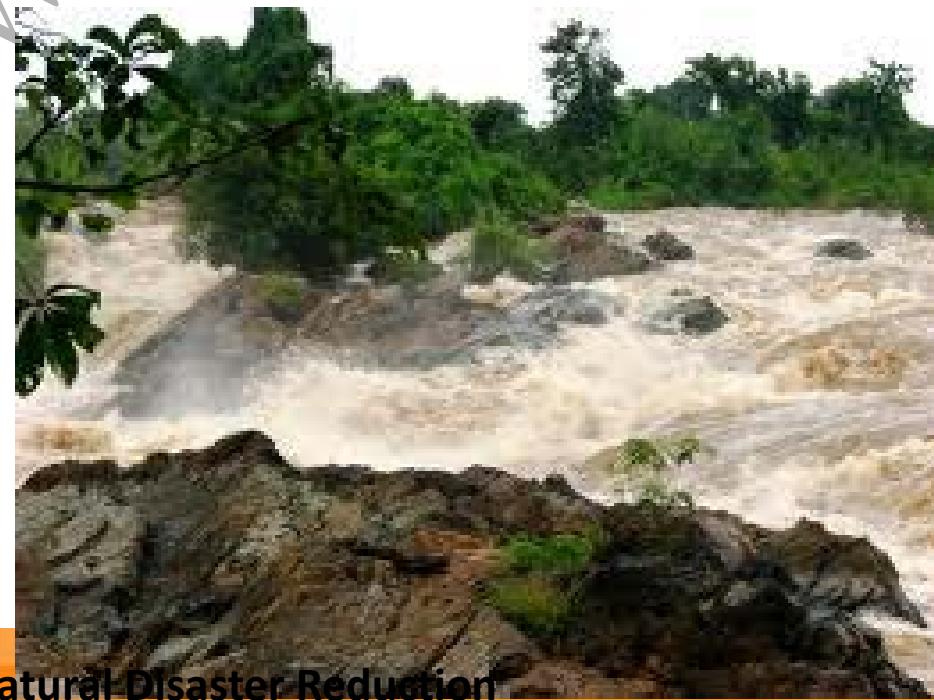
Effect of Water

Water increased pore water pressure
that caused Shear strength of soil
decreased

(Resisting force decrease)

Water increased mass of earth
(Driving force increase)

Factor of safety decrease

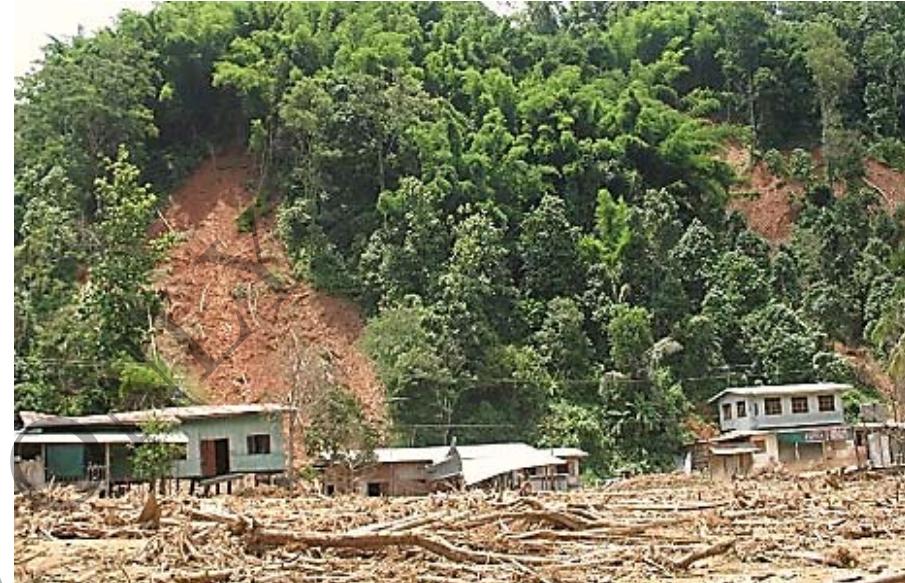
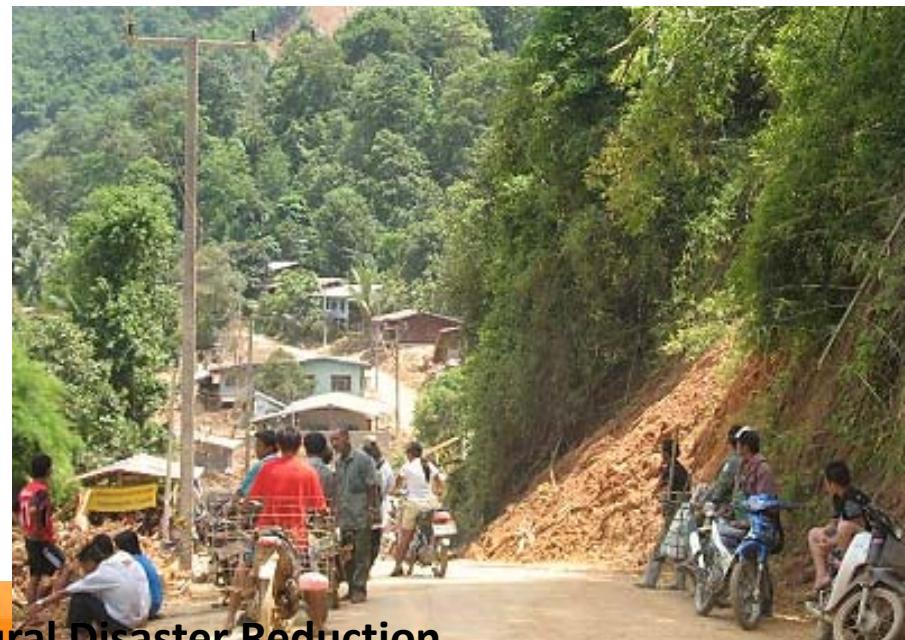
Landslide is depended on two forced:

Driving force : Mass of earth
Slope angle

Resisting force: Shear strength of soil.
(cohesion and friction)

Factor of safety = Resisting force
Driving force

F.S. > 1.25 or higher is acceptable

F.S. < 1.0 failure

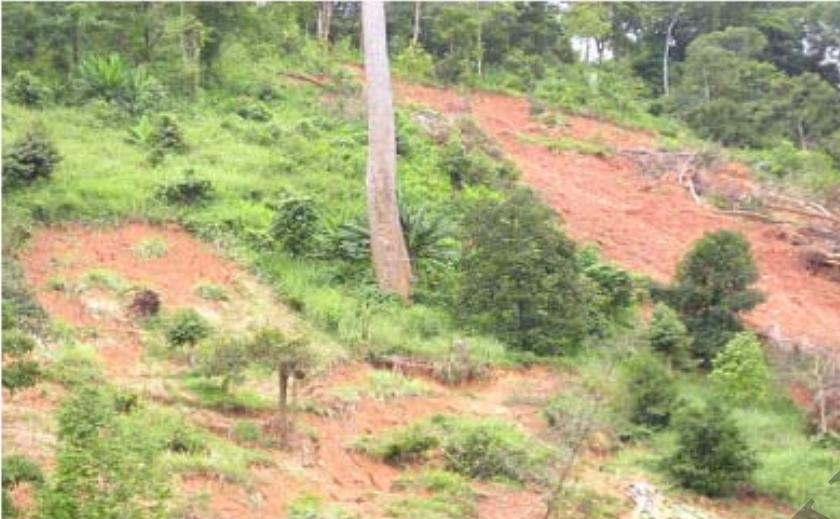
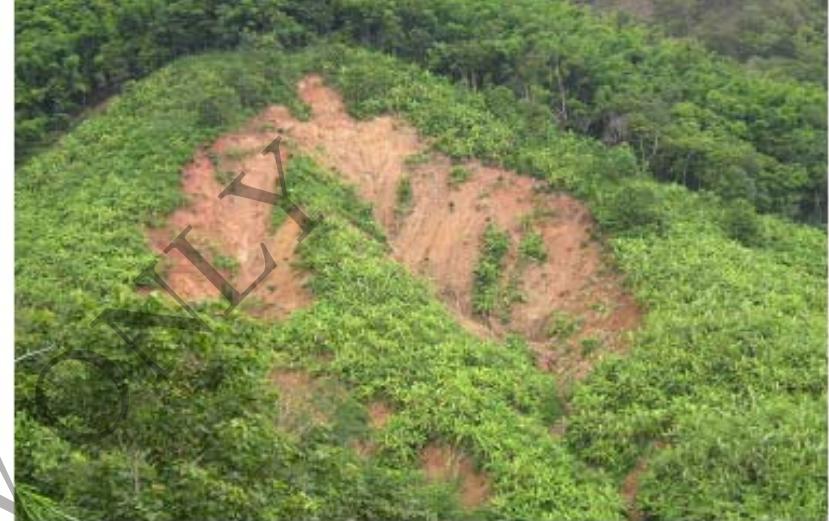
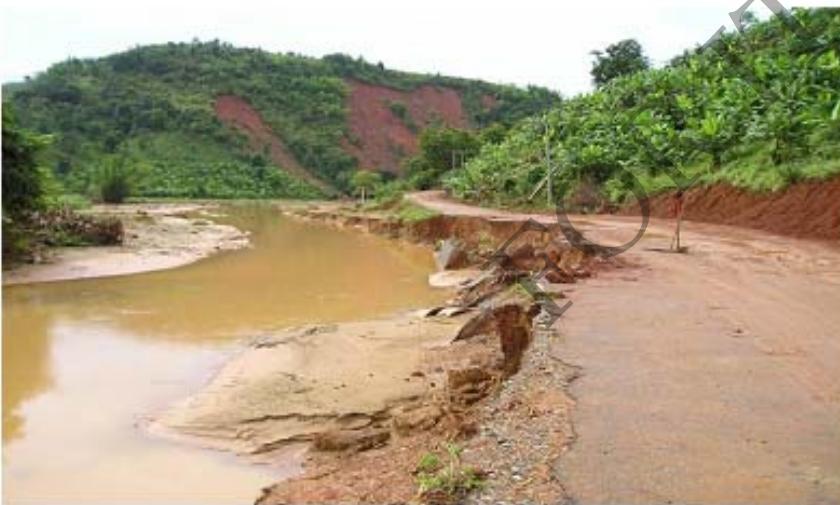
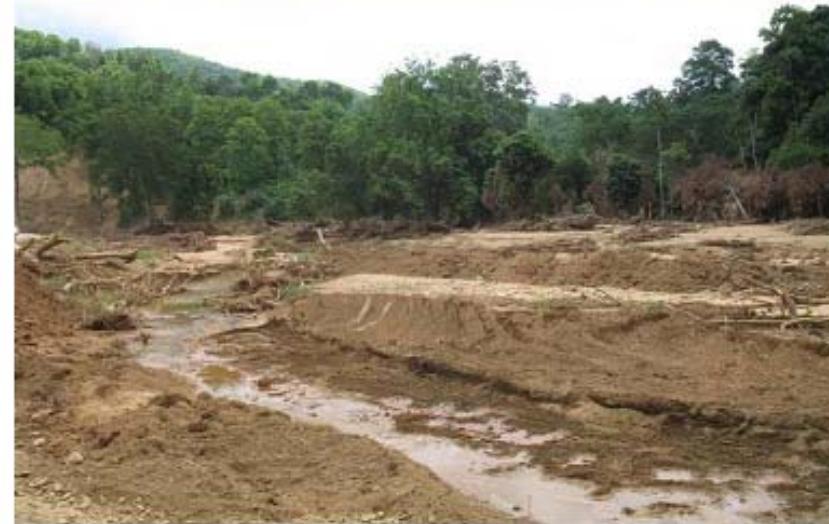
Type of failure

Categorization of the inspected landslide (a) Shallow earth slips (b) Gully erosion (c) Failures of cuttings behind the houses or roadside cuttings and (d) slope or bank failures due to erosion of the foothill and destabilization of upslope area.

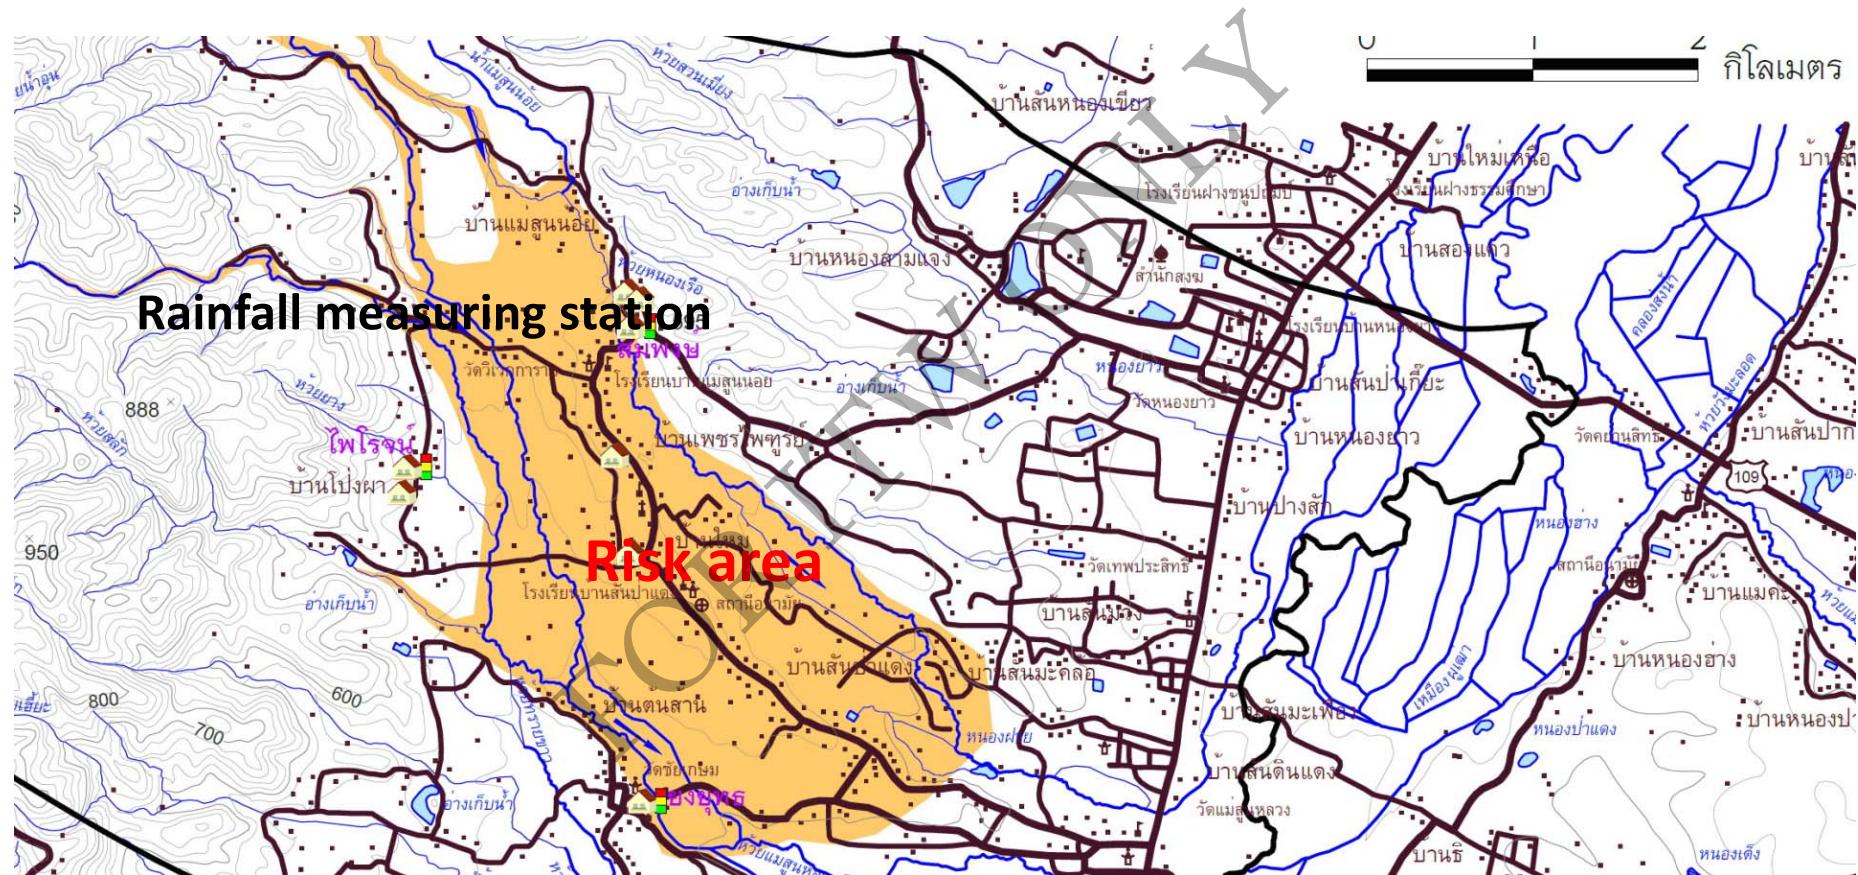
Relationship between Rainfall and Landslide

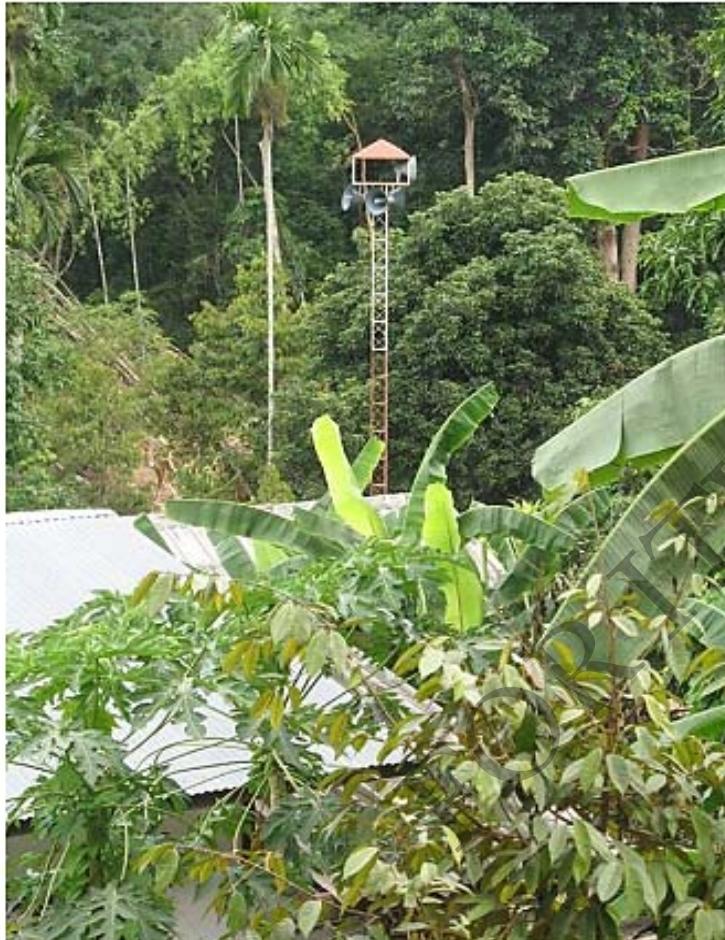
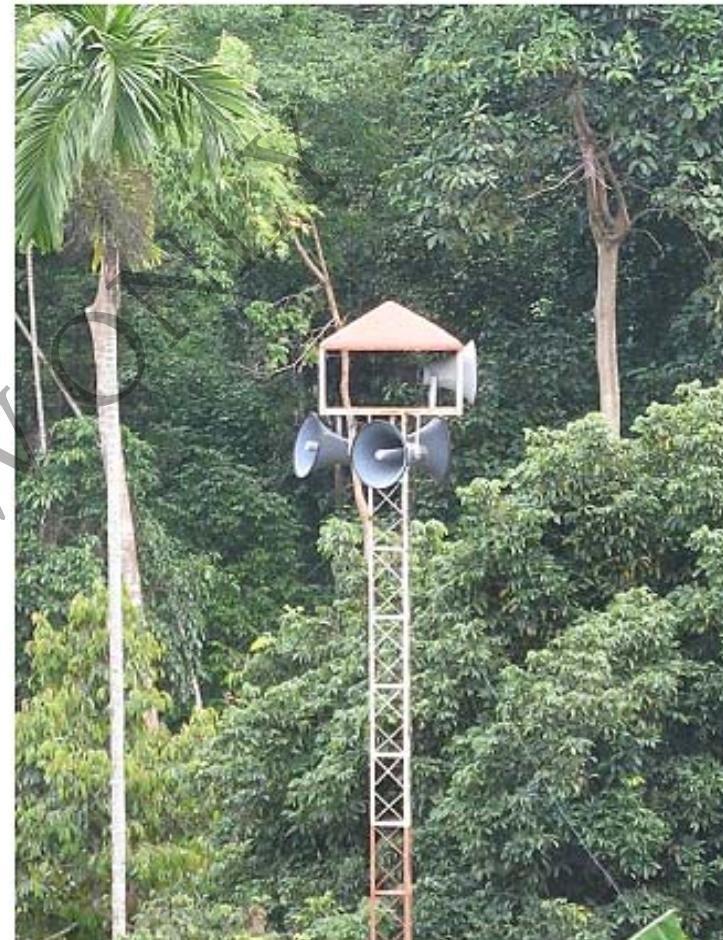
Warning system

The public address system for the community. There is a need for establishing the community-based early warning system.

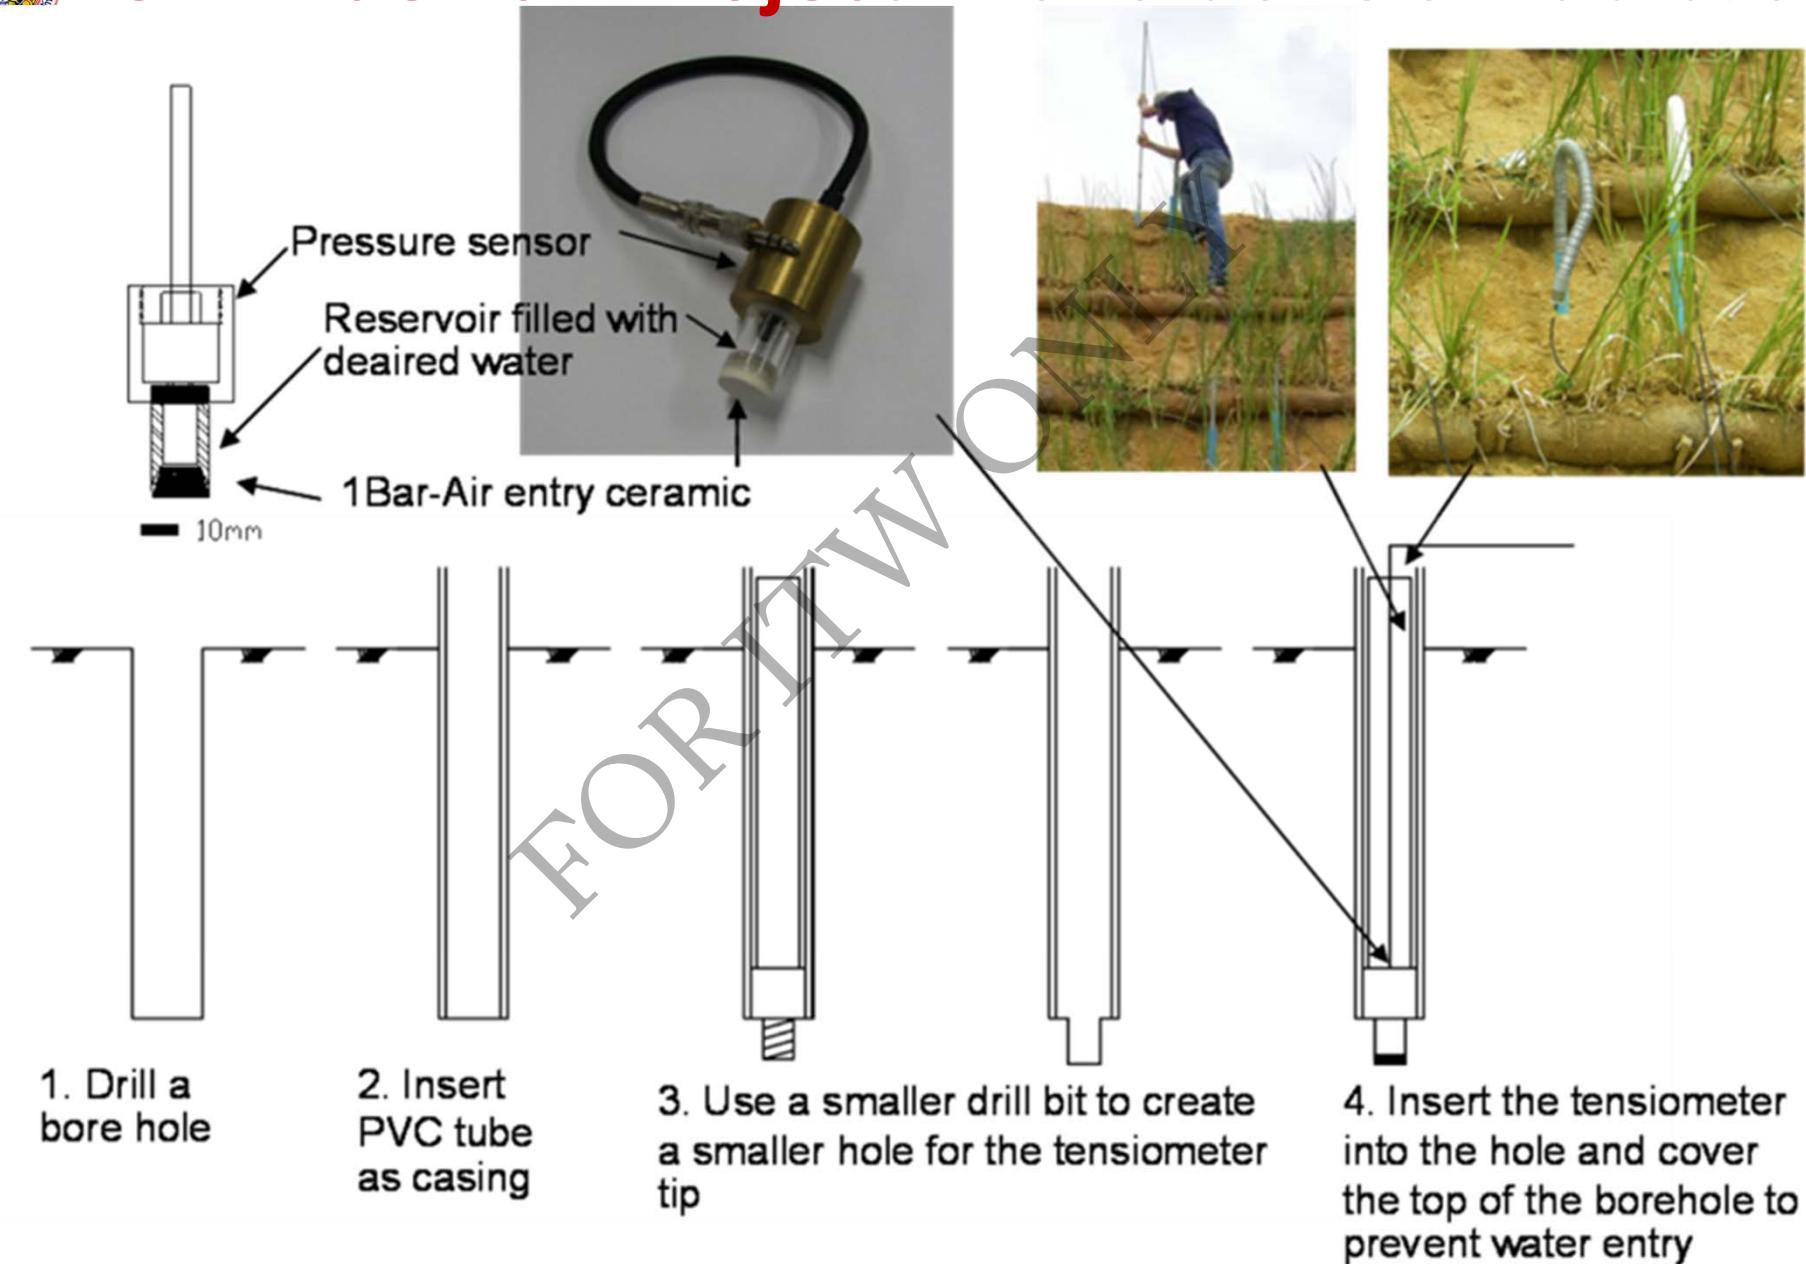
Kew Mae Pan Project : KU-Tensiometer installation

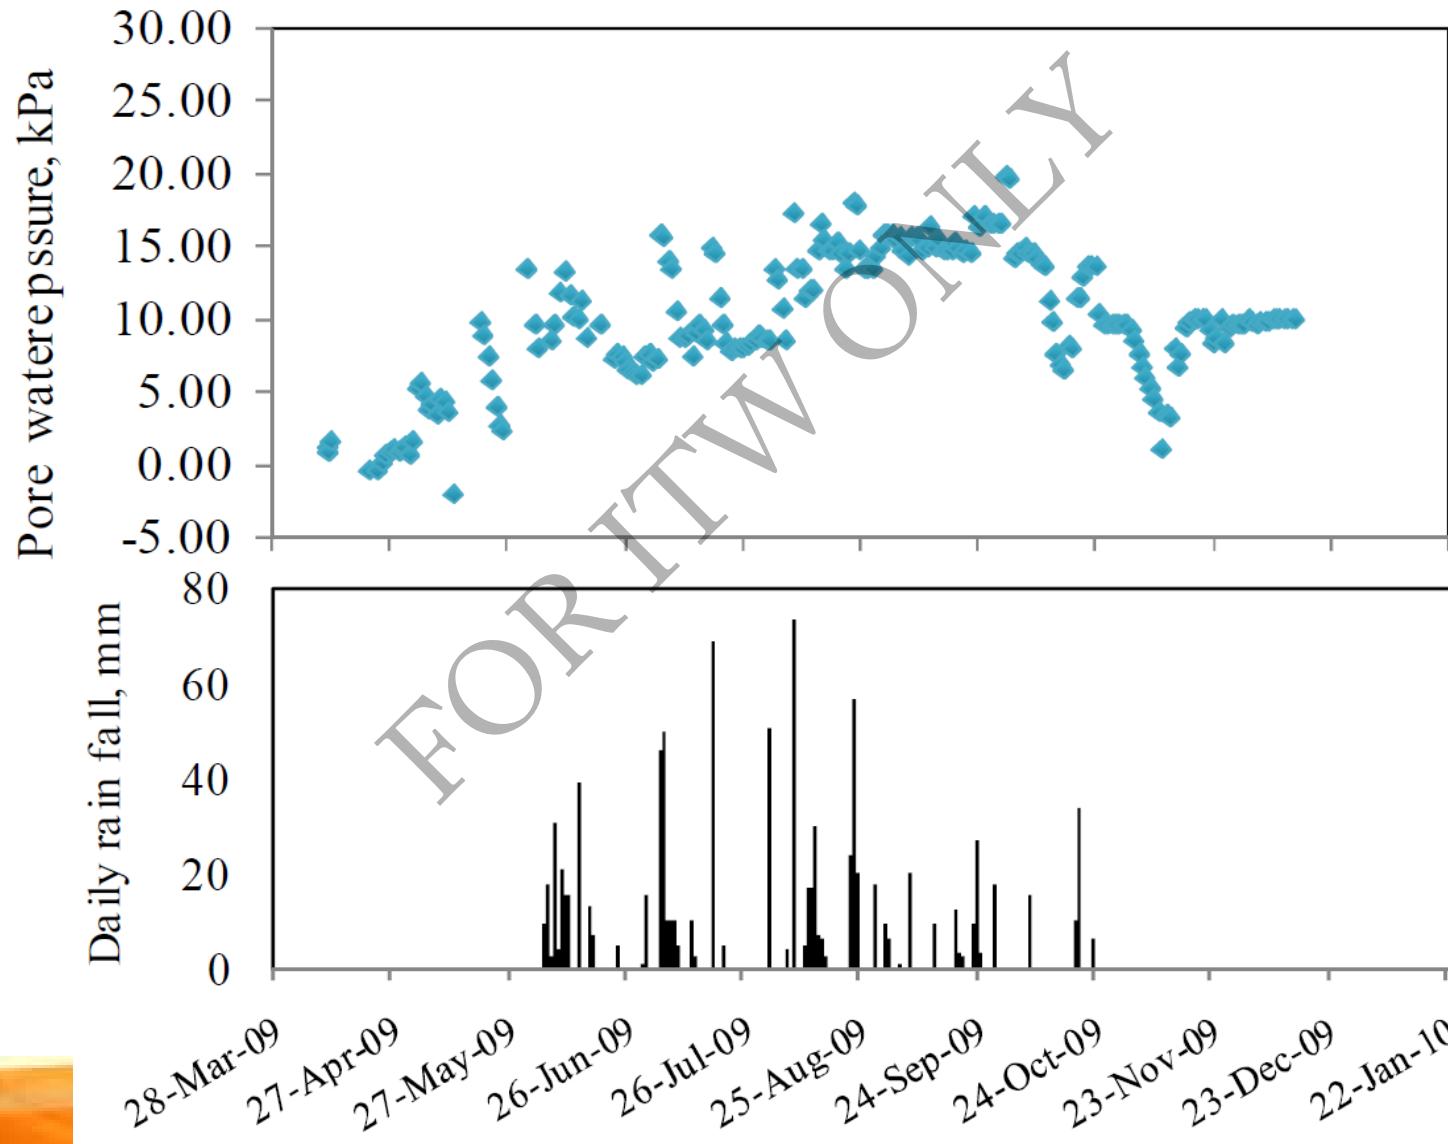
KU-Tensiometer

Variation of daily rainfall and corresponding pore-water pressure

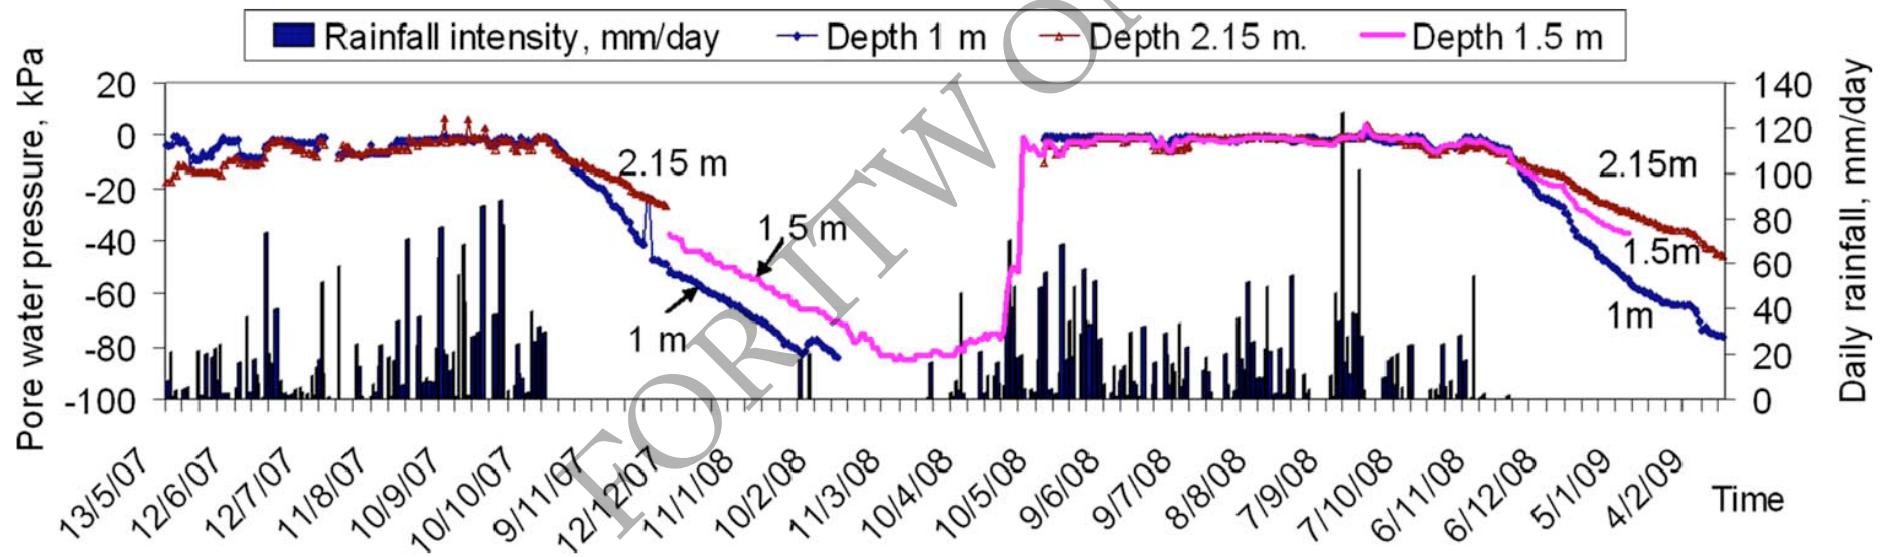
KU-Tensiometer

Variation of rainfall and corresponding pore-water pressure

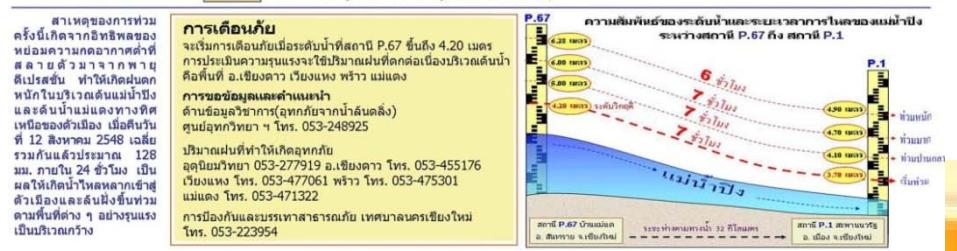
ลำดับการขึ้นท่วม	1 3.70 เมตร (304.20 ม.- รถก.) ปริมาณ 460 ลบ.ม./ว.	5 4.20 เมตร (304.70 ม.- รถก.) ปริมาณ 578 ลบ.ม./ว.
เมืองน้ำปีงที่สถานี P.1	2 3.90 เมตร (304.40 ม.- รถก.) ปริมาณ 509 ลบ.ม./ว.	6 4.30 เมตร (304.80 ม.- รถก.) ปริมาณ 601 ลบ.ม./ว.
สะพานน้ำรัชช์สิงห์ระดับ	3 4.00 เมตร (304.50 ม.- รถก.) ปริมาณ 532 ลบ.ม./ว.	7 4.60 เมตร (305.10 ม.- รถก.) ปริมาณ 673 ลบ.ม./ว.
	4 4.10 เมตร (304.60 ม.- รถก.) ปริมาณ 556 ลบ.ม./ว.

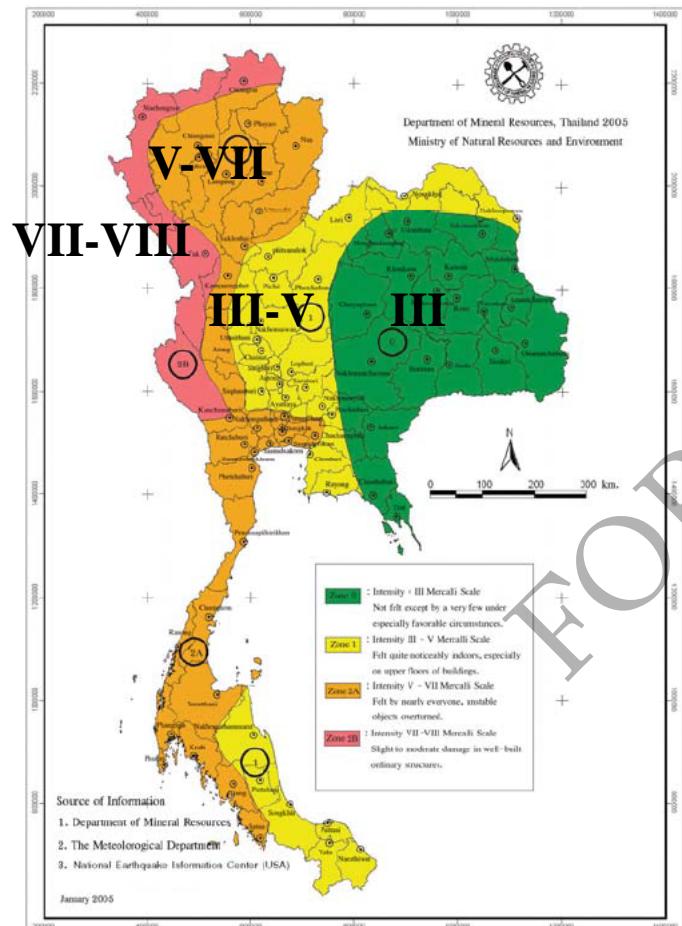
Seismic Hazard Map of Thailand in Modified Mercalli scale (MM)

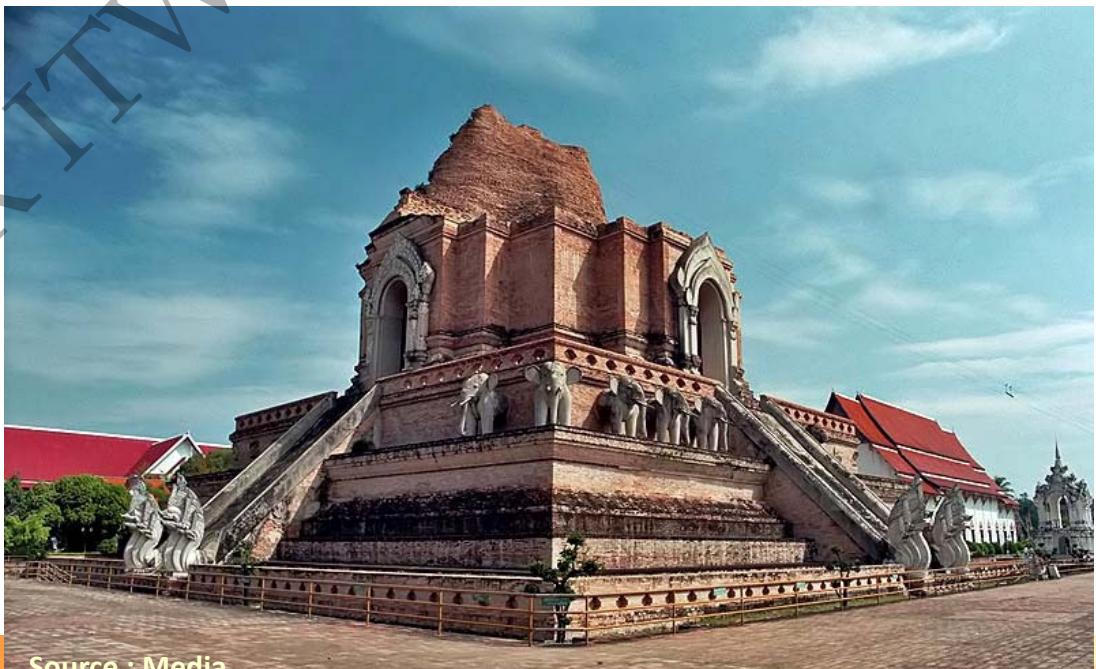
In 1545, The Chedi Loung (The big stupa)

The upper 26 m from 86 m of the structure collapsed after an earthquake (Ref : The Fine Arts Department)
