Natural Hazards caused by Typhoon Morakot in Taiwan

SHIEH, Chjeng-Lun

**Disaster Prevention Research Center,
National Cheng-Kung University**

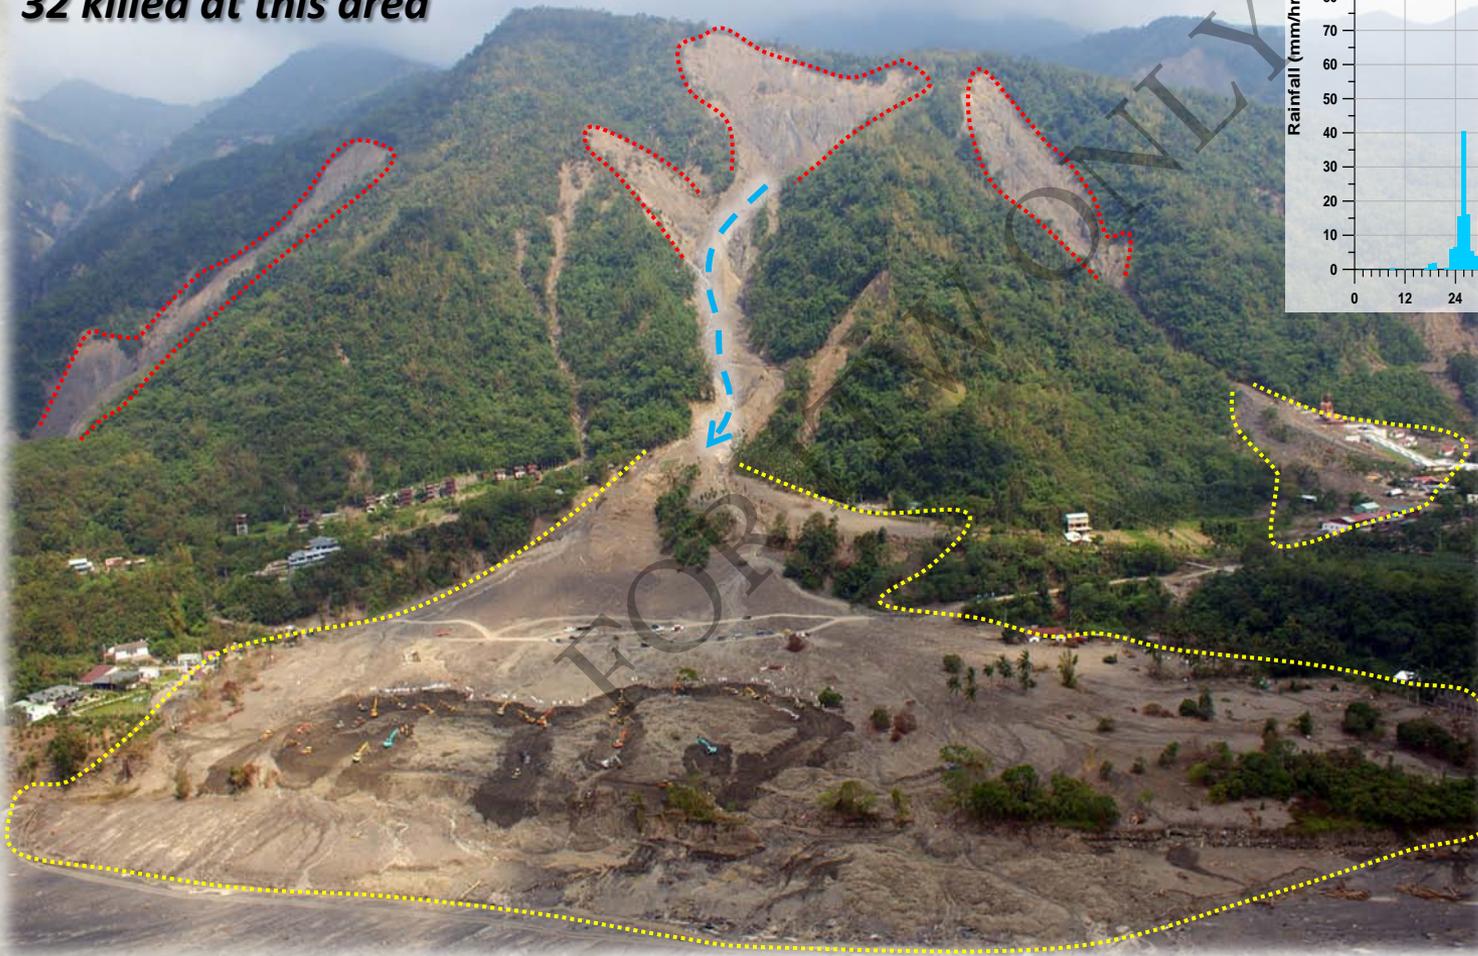
Example for Shinkai (新開) Village

32 killed at this area

I = 98 mm/hr
R = 2342 mm
新發雨量站

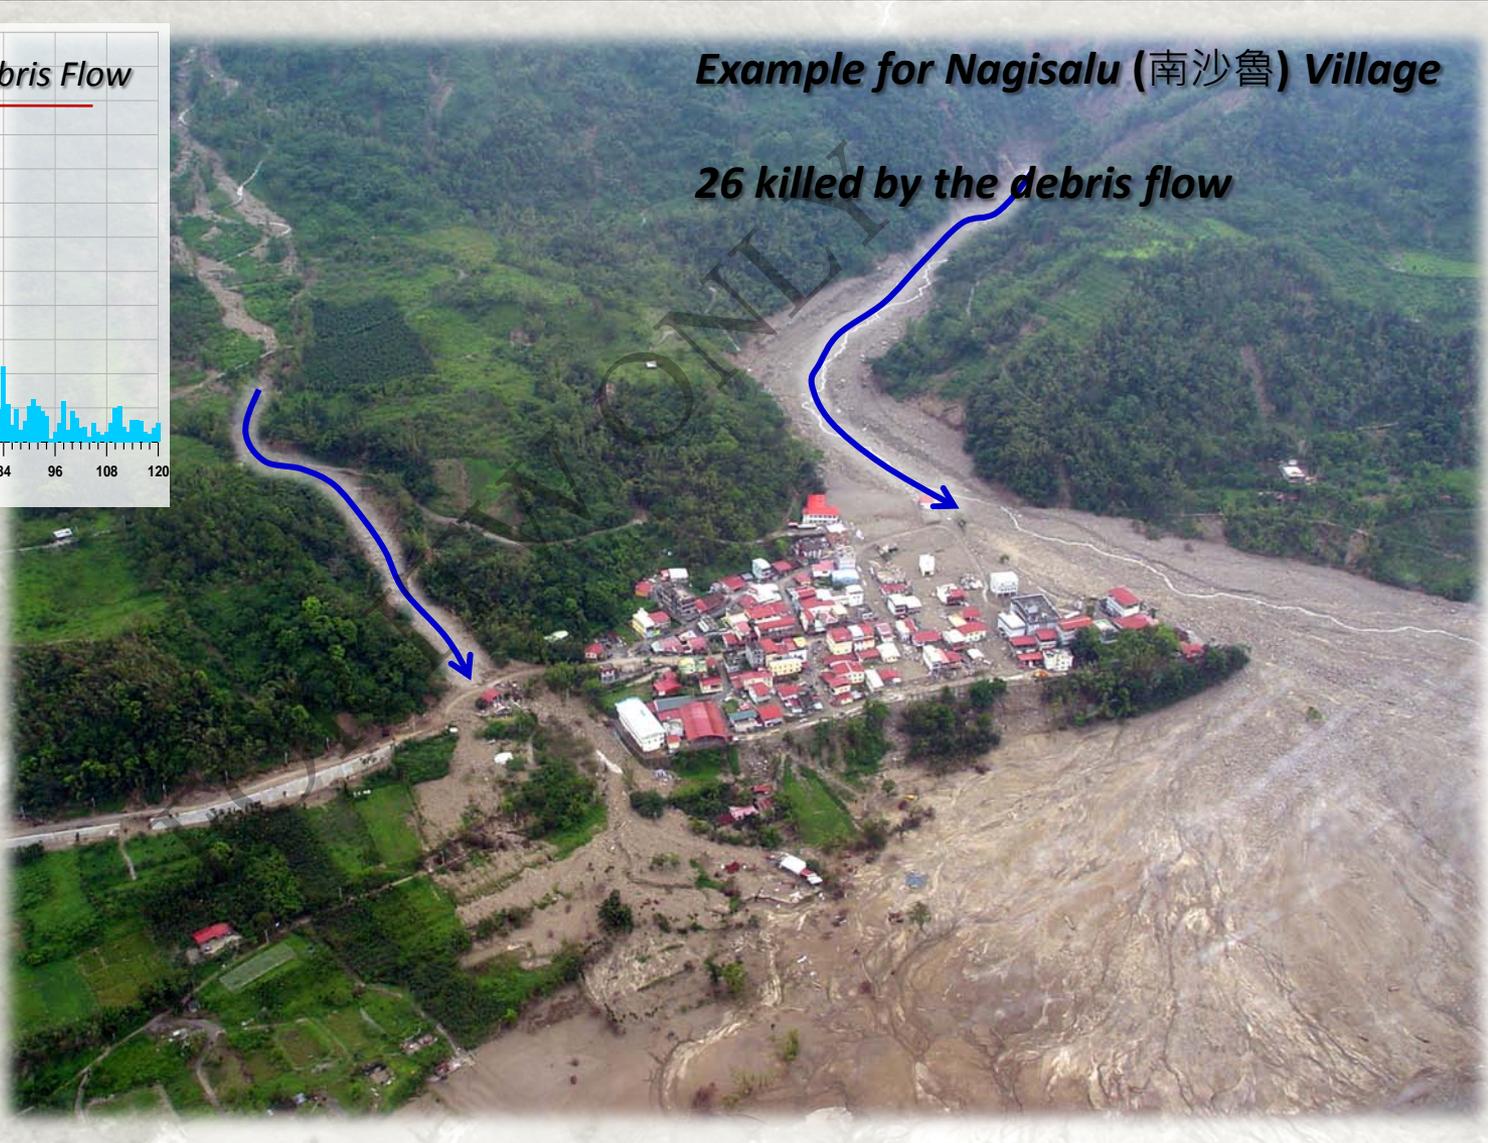
Example for Nagisalu (南沙魯) Village

$I = 88 \text{ mm/hr}$
 $R = 2074 \text{ mm}$
甲仙雨量站

26 killed by the debris flow

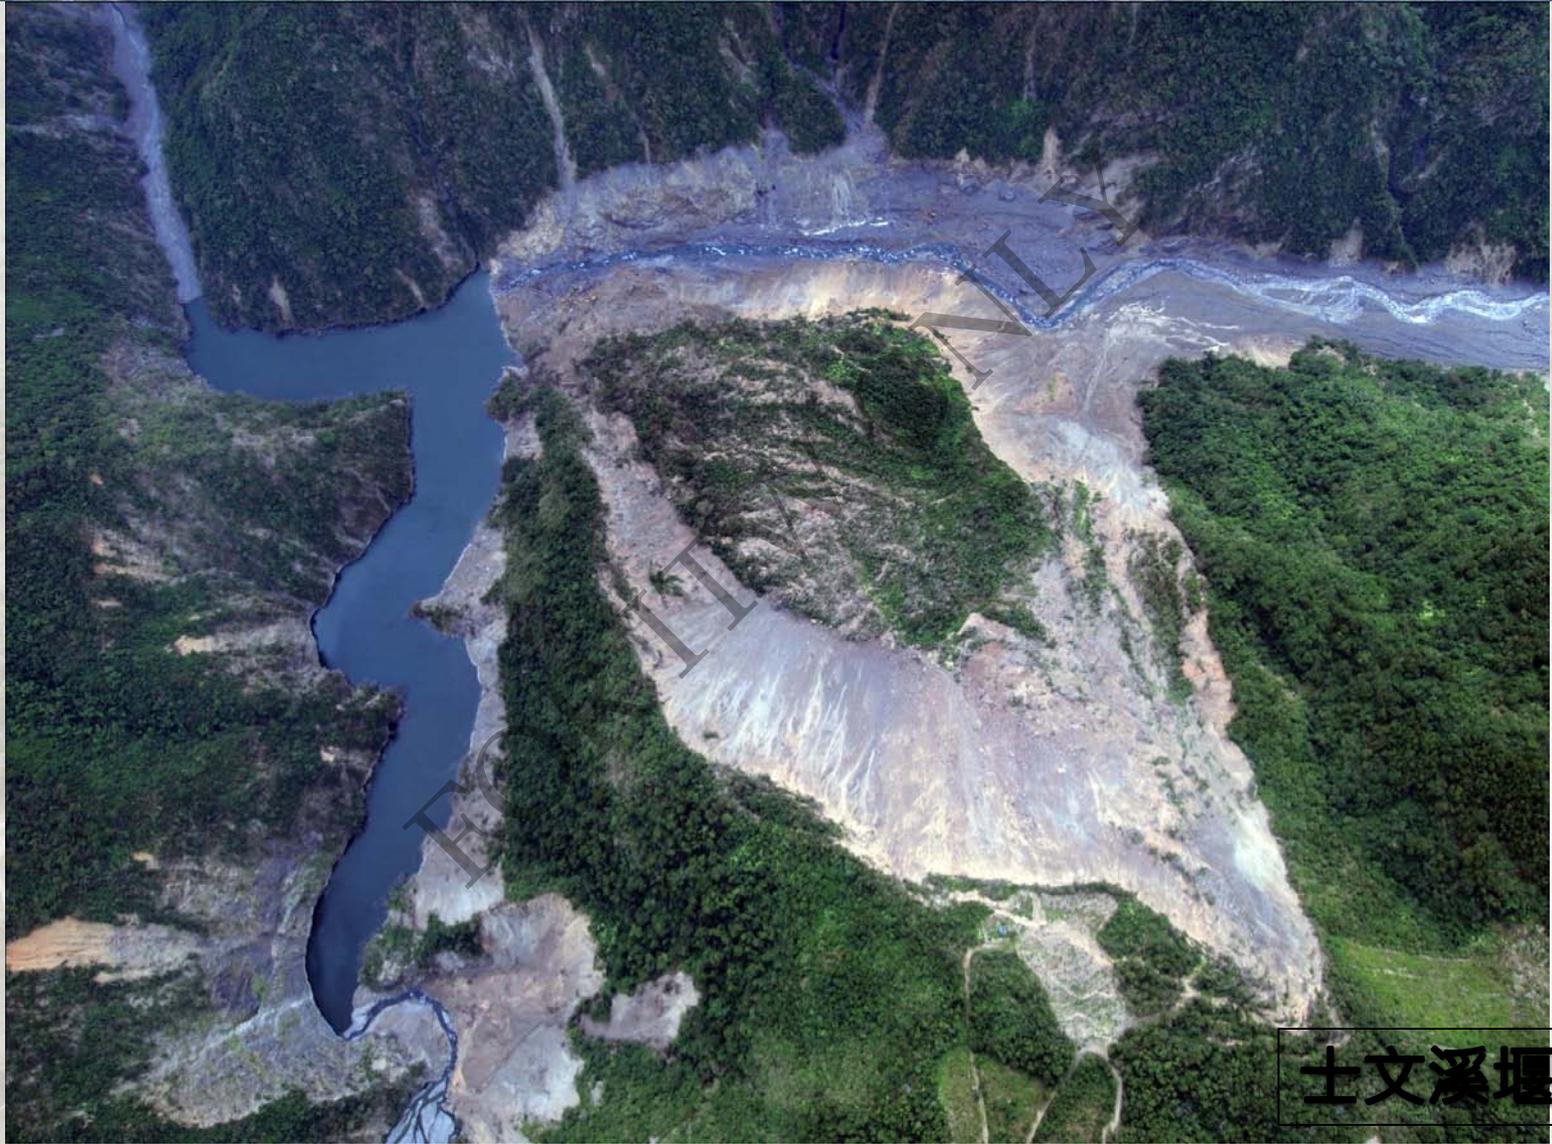
士文溪堰塞湖

3.2 Disasters in Mountainous Area (Landslide Dam)

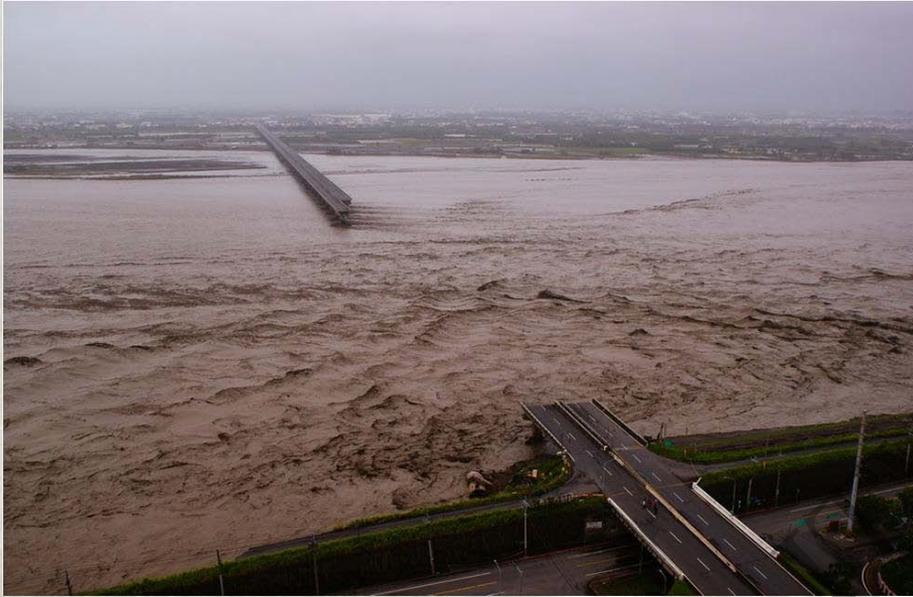
3.3 Disasters in Plain Area (Bridge Break)

- 雙園大橋(Swan-Uen Bridge)
- 高屏溪(Kaoping River)
- Break Length 459m
- 6 persons missing (at least)

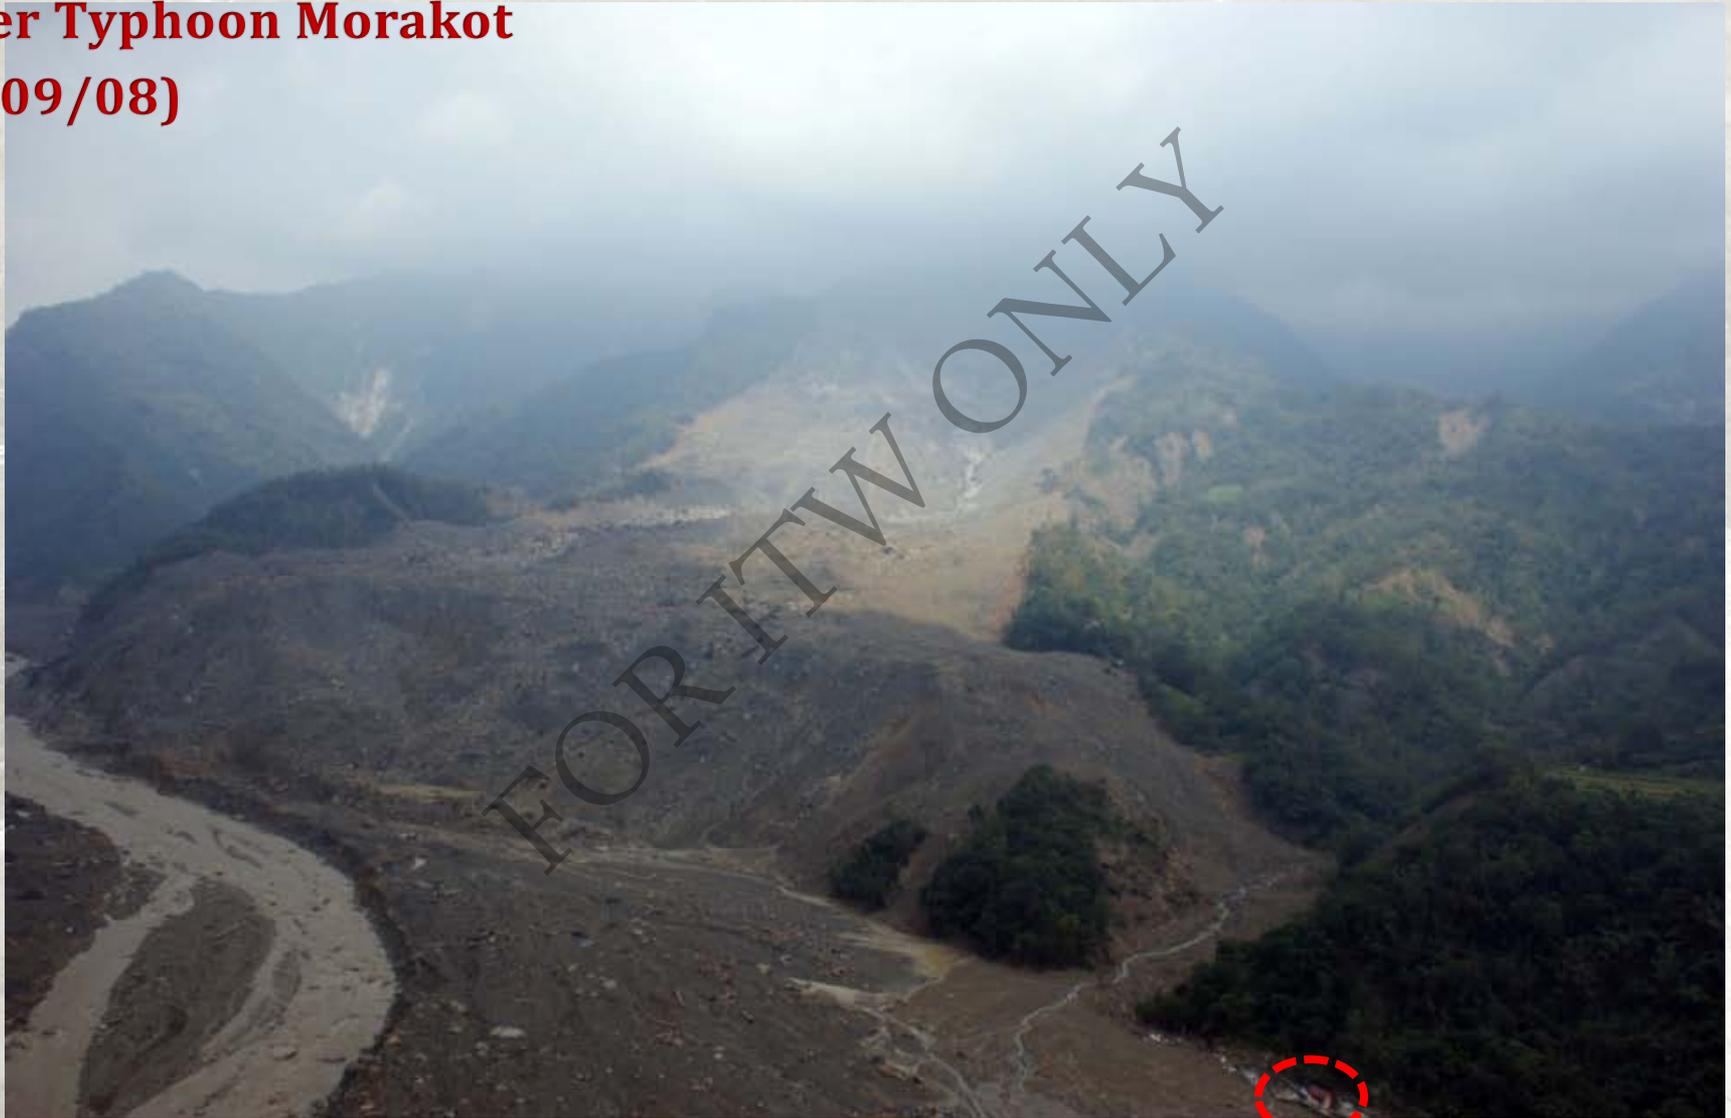
After Typhoon Morakot
(2009/08)

More than **400** people in xiaolin village were killed

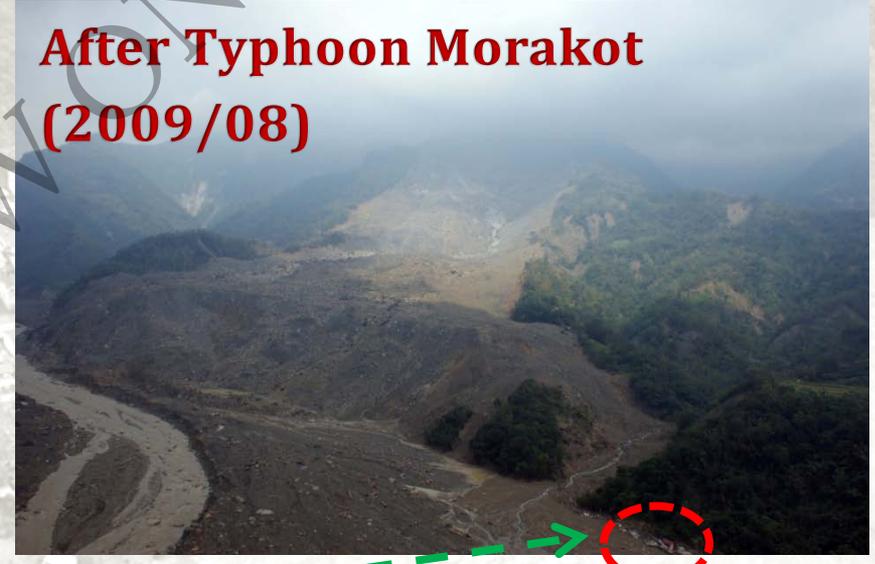
The only remaining building in Siaolin village after the landslide
