# Disasters Caused by Typhoon Morakot in Taiwan and the Renovation Strategy

The purpose of this paper is to provide the information of disasters caused by Typhoon Morakot in Taiwan and the corresponding renovation strategy. The torrential rainfall is regarded as the main cause of the disasters and hence the information of the torrential rainfall is first given in this paper. The isohyets of cumulative rainfall depth are prepared. Storm centers can be found in the isohyets. The storm centers have important meanings to disasters resulted from Typhoon Morakot, because many severe disasters occurred around the storm centers or in the downstream areas of the storm centers. Disasters induced by Typhoon Morakot include floods, landslides, landslide dams, driftwoods, and disruptions of water supply. Some of these disasters occurred simultaneously or consecutively in one place. Such disasters are defined as the compound hazard in this paper. Current warning systems for single disasters are perhaps not sufficient to handle the compound hazard. It is suggested that we need to develop a new system to early issue warnings for the compound hazard. A systematic methodology to plan the strategies

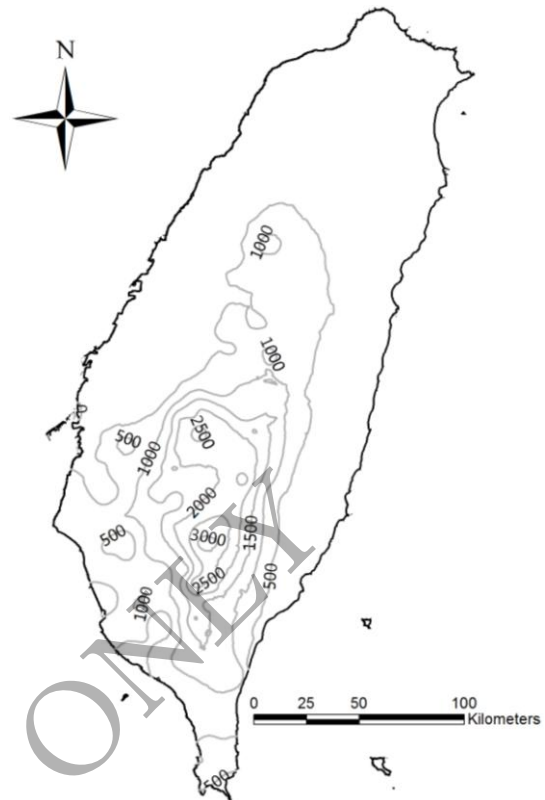
Fig. 5 Isohyets of Taiwan during Typhoon Morakot. Isohyets are in mm depth of total rainfall

The isohyets of cumulative rainfall depth for Taiwan during Typhoon Morakot are depicted in Fig. 5. From Fig. 5, it can be found that the heavy rainfall covered whole Taiwan during Typhoon Morakot. Therefore, it is said that one characteristics of the rainfall of Typhoon Morakot is large-extent.

Storm centers can be observed in the southern area of Taiwan from Fig. 5. The locations of the storm centers have strong connections with the disasters. Most of severe disasters, including

landslides and landslide dams, occurred surrounding the storm centers. Flood occurred in the downstream areas of the storm centers as well.

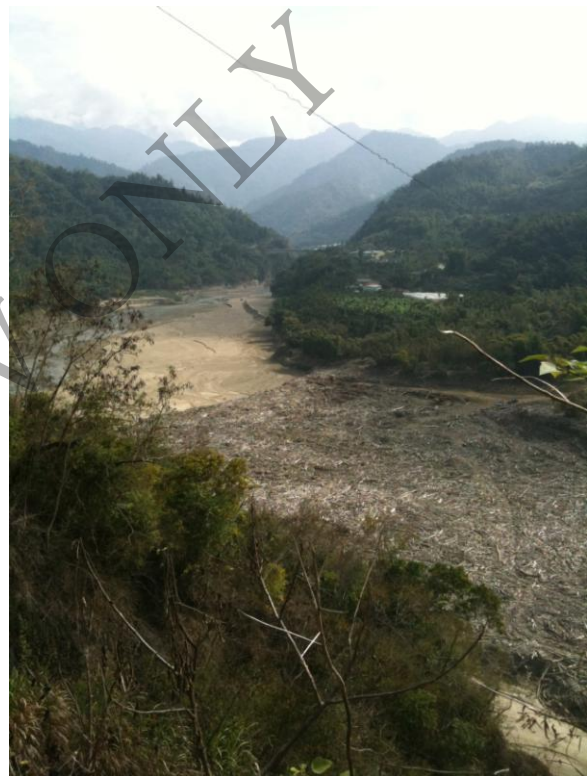
Fig. 12 Driftwoods in the Tsengwen reservoir

From our field investigation, the driftwoods were observed in the downstream areas of the storm centers. For example, Fig. 12 shows the driftwoods observed in the Tsengwen reservoir.
