Dike Damages (built by WRA)

Serious River & Reservoir Sedimentation Problem

III、Progress of Morakot Disaster Recovery

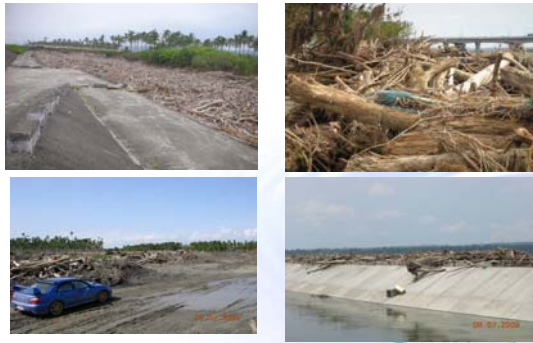
Some Dikes were broken by Tree Debris

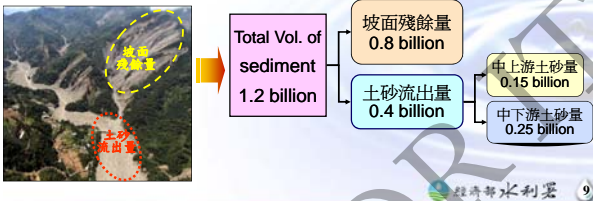
- More than 394.92 Km² hill collapse or land slide during Morakot
- The Land collapse produced 1.2 billion m³ sediment. Only 0.4 billion m³ was taken with flood, 0.8 billion m³ sediment was still accumulated on hill slope.

Hill Collapse, Land slide, Debris flow and Natural reservoir always induce casualties

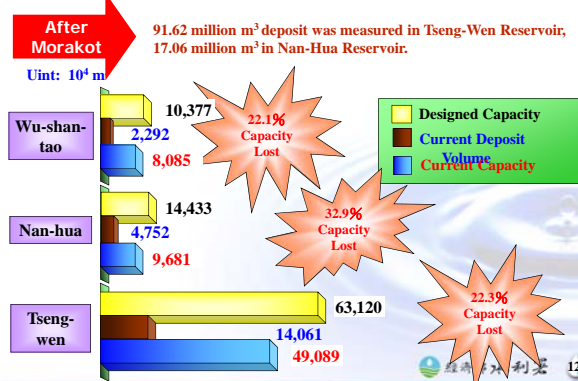
Deposit suddenly Increase in Reservoirs

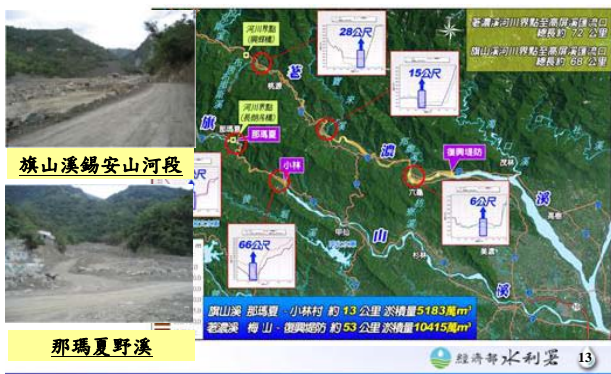
River Bed Raised and Main-stream Channel Changed

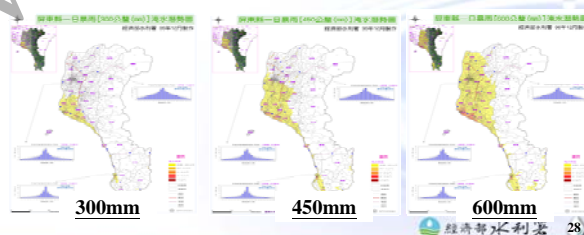
➢ The first Pre-Warning system Combine pre-simulated inundation potential May(Hazard May) and Rainfall estimation from CWB

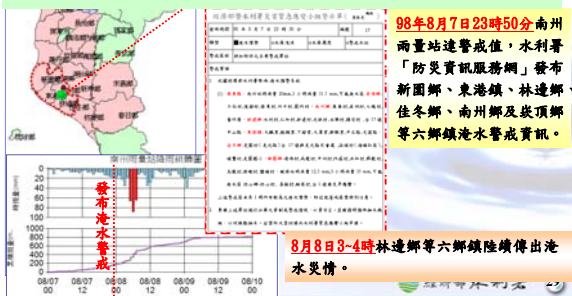
➢ The second Pre-Warning System catch the information from current precipitation and then estimates what places will inundate in the following 2~3 hours.

8月8日3-4時林邊鄉等六鄉鎮陸續傳出淹水災情。

Pre-Warning Messages will send to

- Central Disaster Mitigation Management Center
- Central Weather Bureau
- Local Authorities (Fax)
- Mayor of Townships (Cell Phone Messages)
