Risk study by landslides and debris flows in Santiago Atitlán

Guatemala

CONRED
Guatemala, Centroamérica

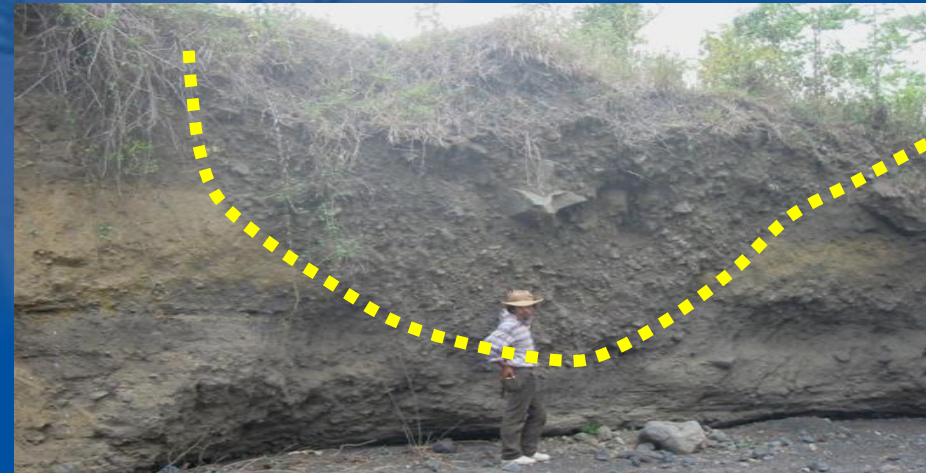
Example paleocanal in the vicinity Santiago Atitlan

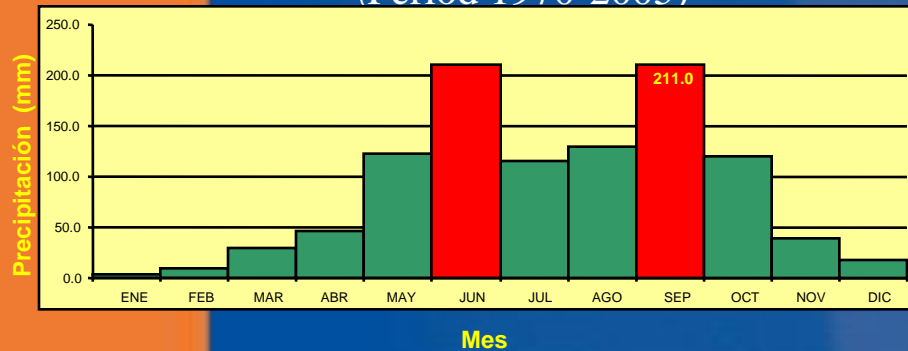
Average monthly rain Santiago Atitlan
(Period 1970-2005)

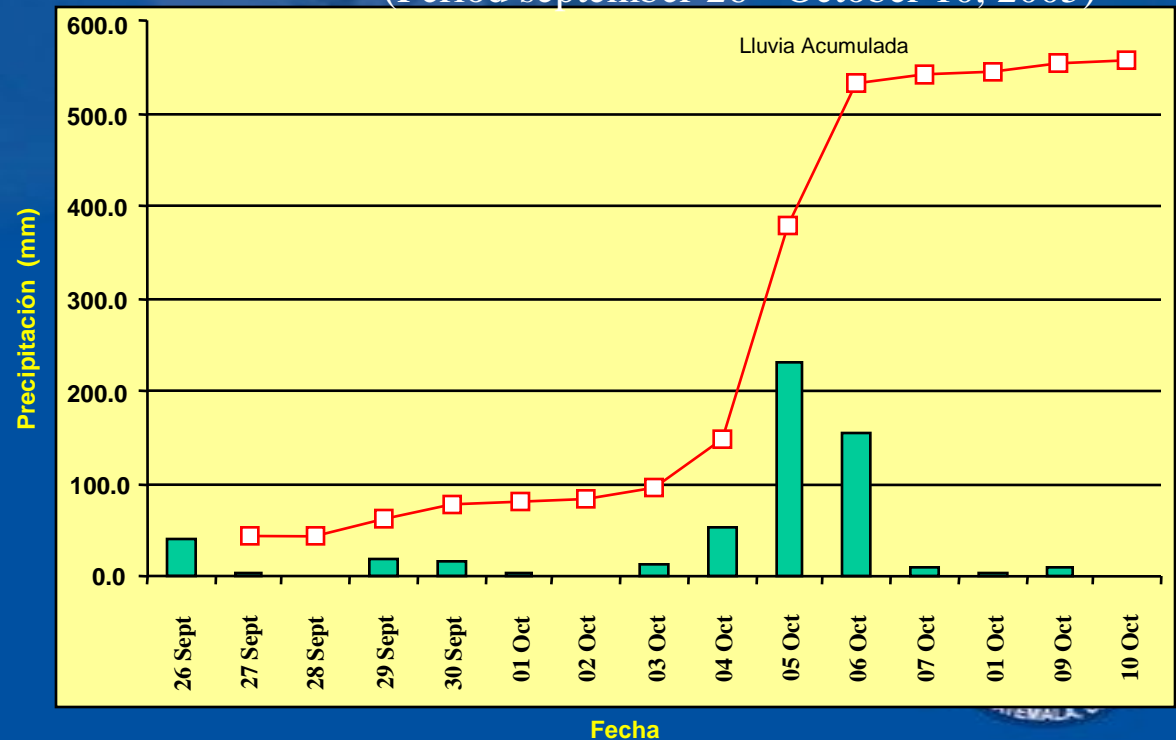
Rains in Santiago Atitlan
(Period september 26 - October 10, 2005)

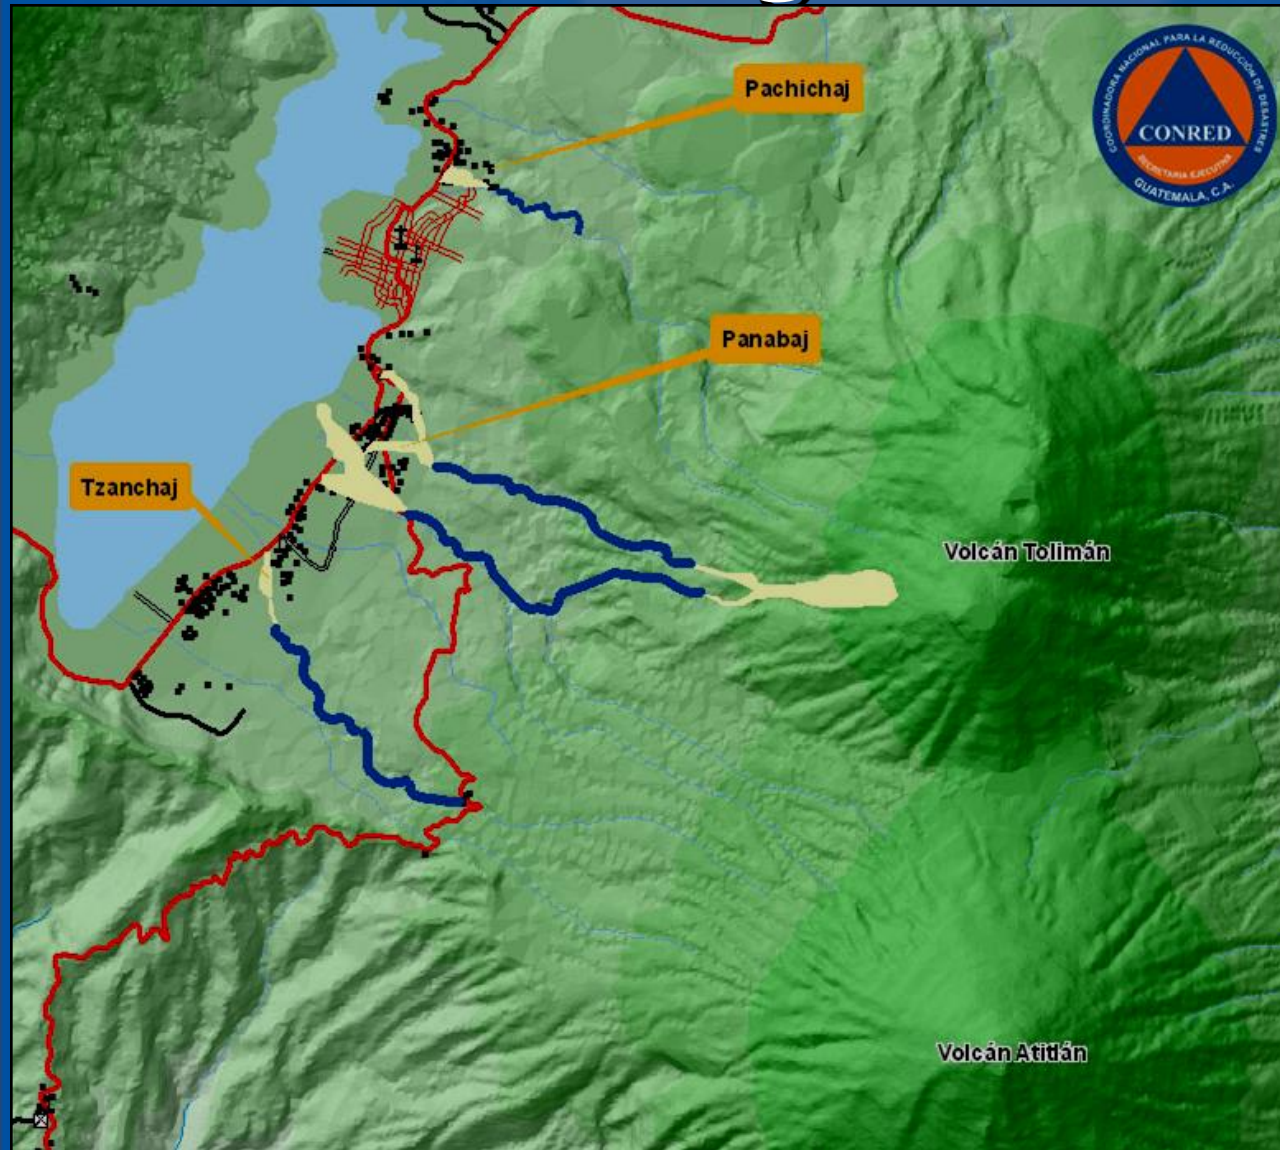
Major events generated in Santiago Atitlan
