2014 International Training Workshop on Natural Disaster Reduction

***When Debris Flow Meets Coffee in Huahan
-A regeneration village from debris flow disasters-***

Hsiao-Yuan(Samuel) Yin Ph.D.

Soil and Water Conservation Bureau, Council of Agriculture

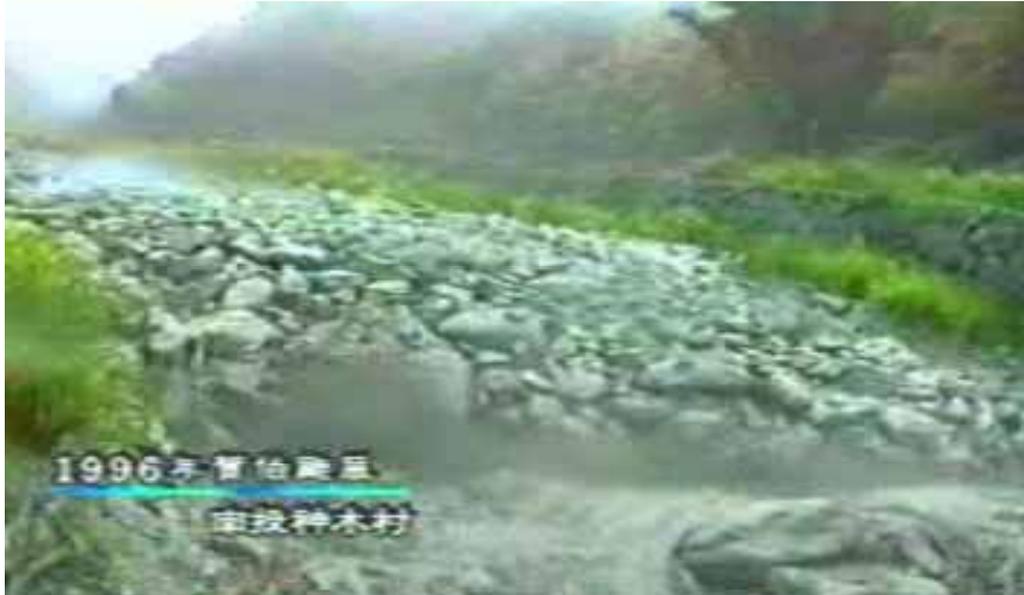
1996-Herb

Debris Flow Disasters in Taiwan

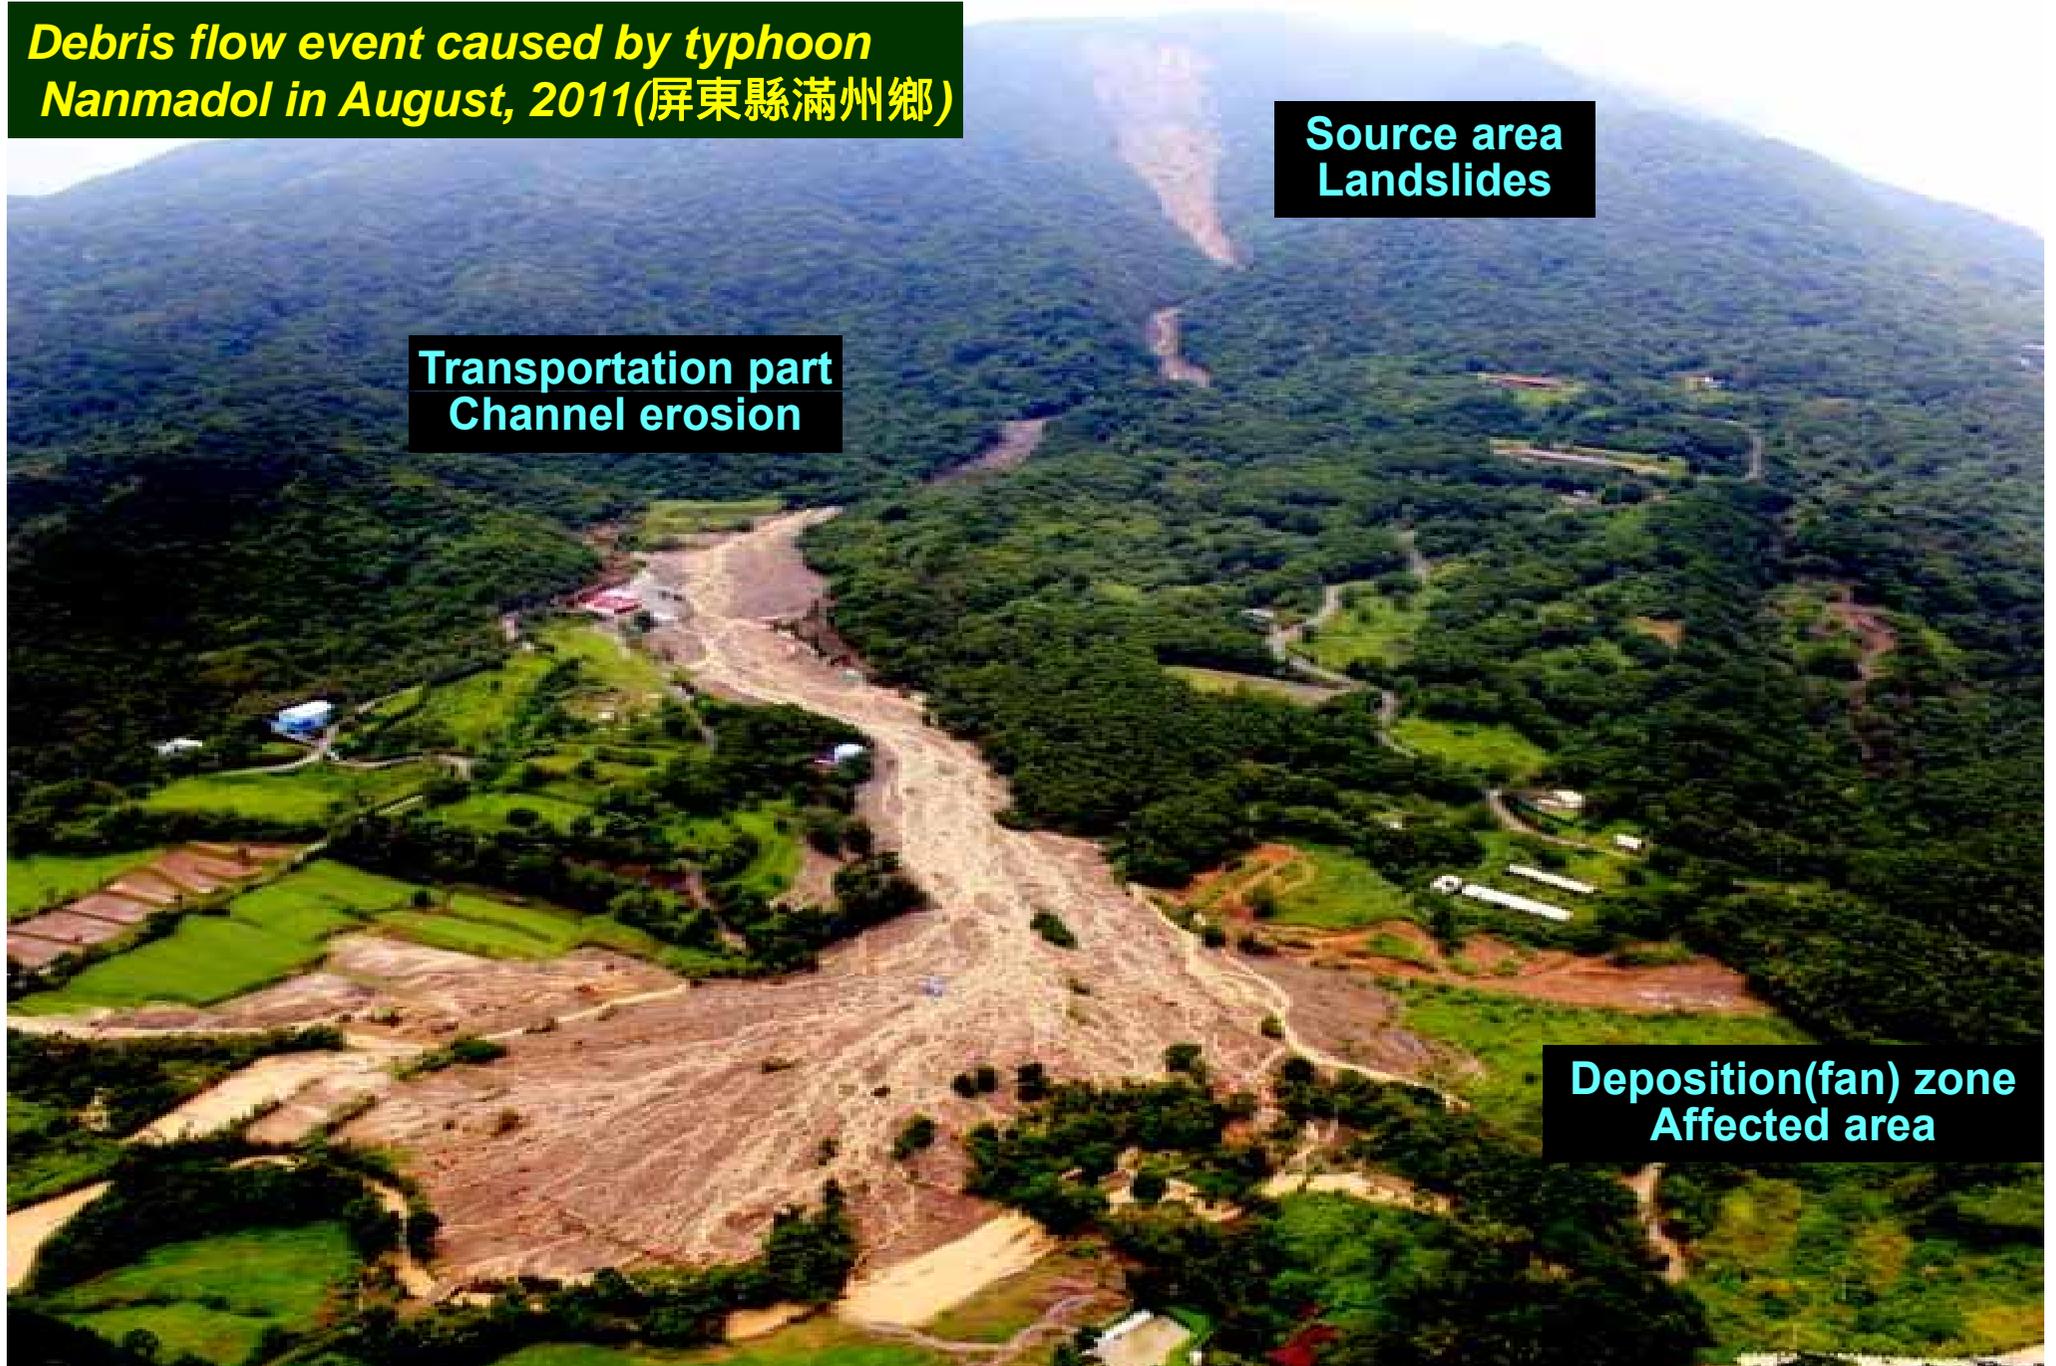
**Debris flow event caused by typhoon
Nanmadol in August, 2011(屏東縣滿州鄉)**

**Source area
Landslides**

**Transportation part
Channel erosion**

**Deposition(fan) zone
Affected area**

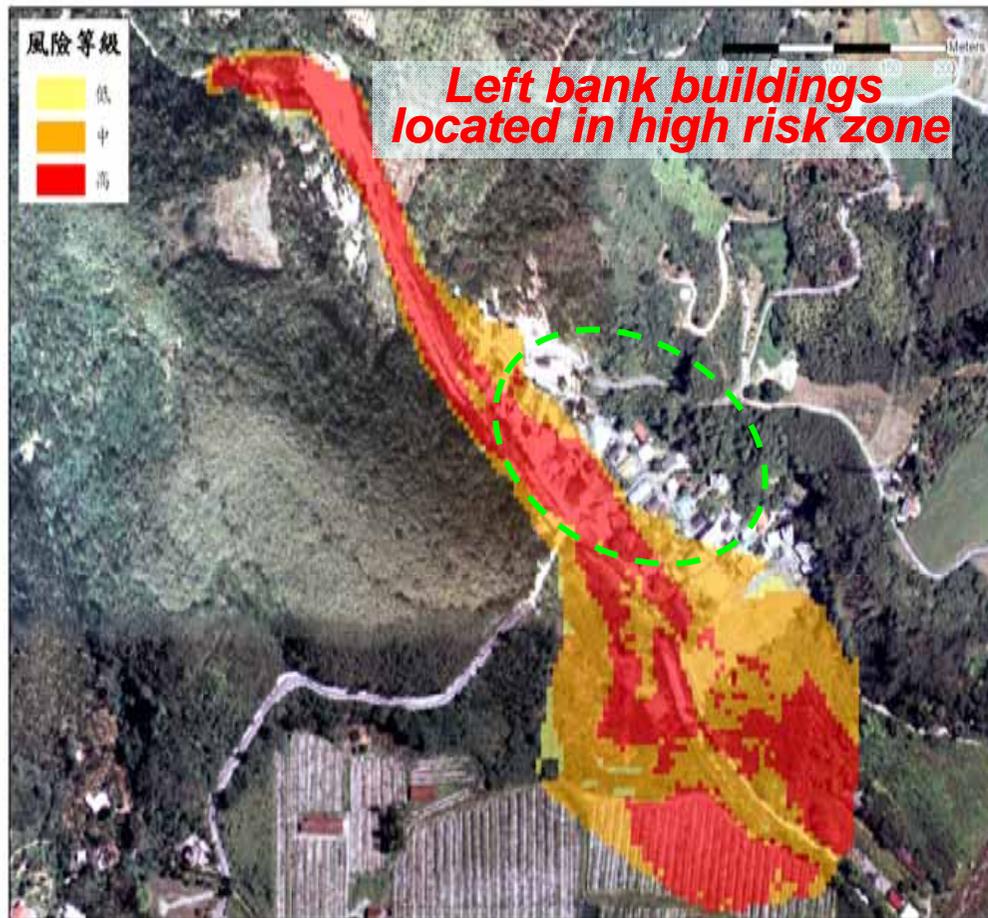
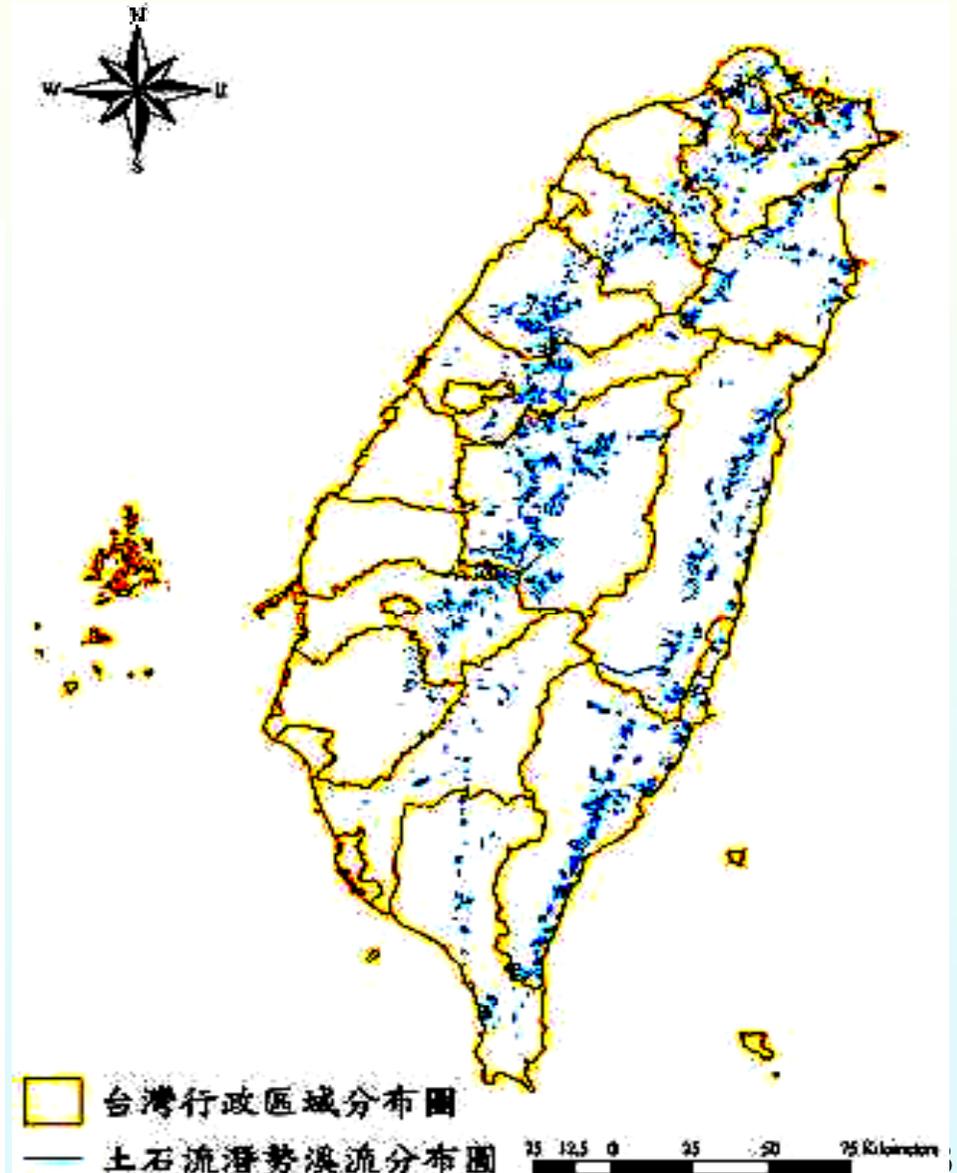
Distribution of 1671 Potential Debris Flow Torrents

Affected area zoning using historic events, semi empirical formula, FLO-2D simulation and on-site survey

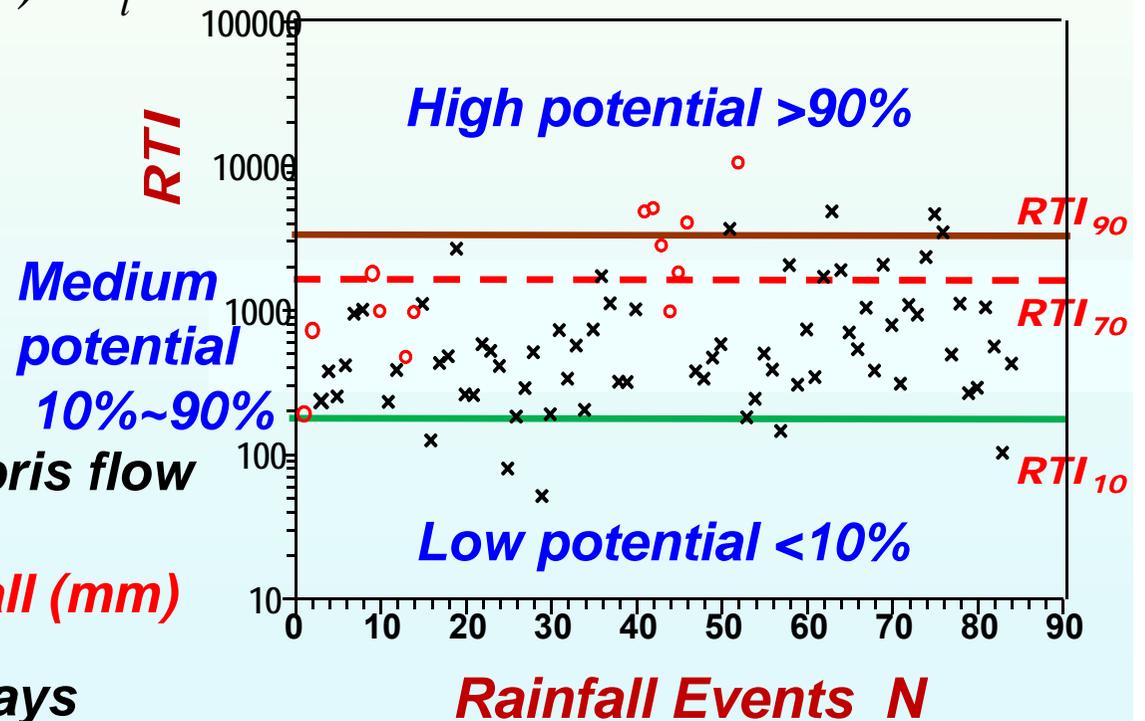
Localized Rainfall-based Debris-flow Warning Model

- **Rainfall Triggering Index (RTI)**
= **Rainfall intensity** × **Effective accumulated rainfall**

$$RTI = I \times R_t$$

$$R_t = \sum_{i=0}^7 (\alpha)^i R_i$$

α is the decaying weighting factor = 0.7

I : Rainfall intensity (mm/hr)

RTI_{70} : 70% RTI value as the debris flow warning criteria

R_t : Effective accumulated rainfall (mm)
= Accumulated rainfall
+ Preceding rainfall for 7 days

X : debris flow do not occurred
O : debris flow occurred

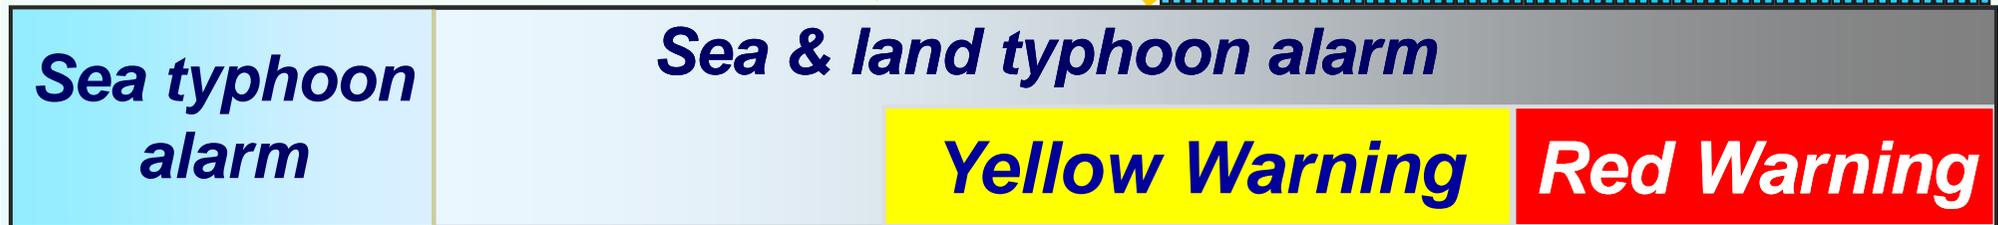
■ **Rainfall Threshold for Debris Flow Warning : 200 600mm**

Predict rainfall > Threshold

Real rainfall > Threshold

-30hr.

-18hr.

-12hr.

Accumulated rainfall

Rainfall forecast

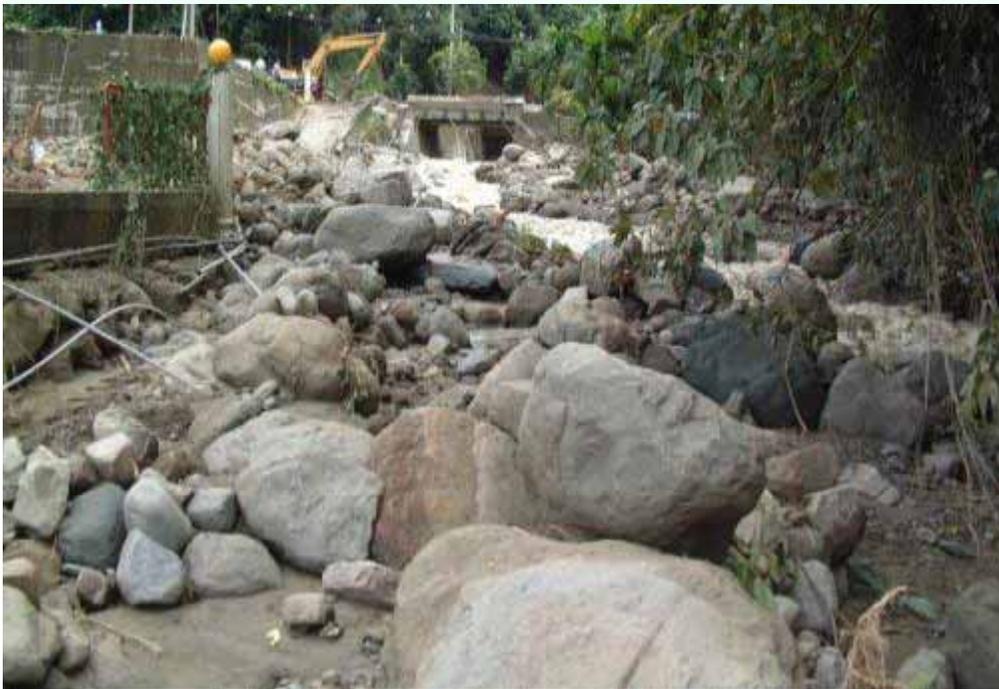
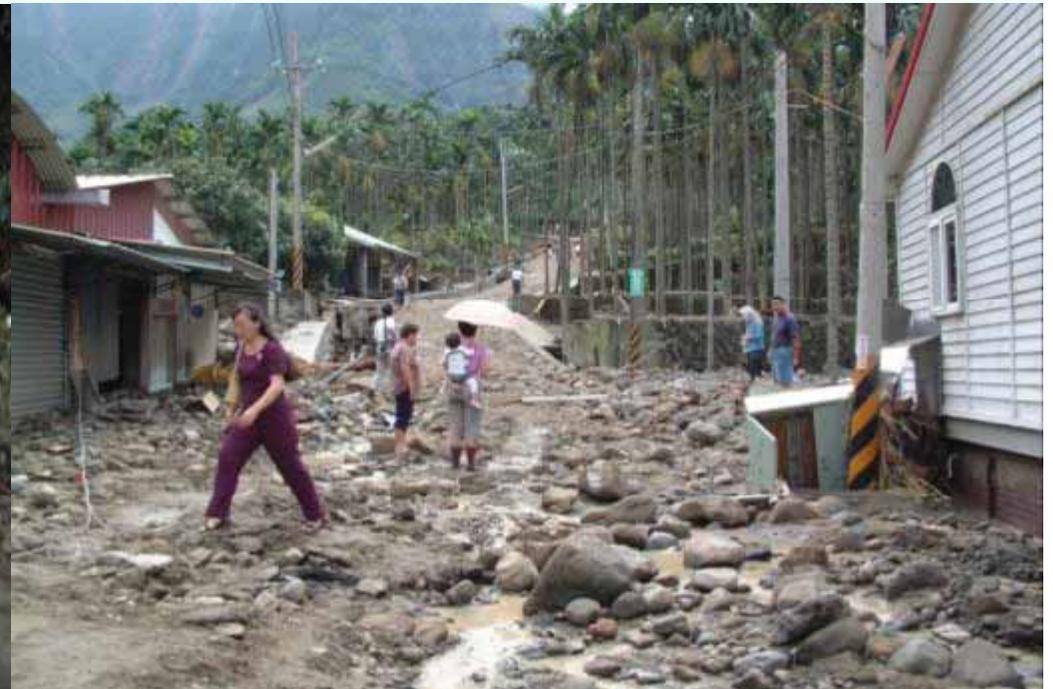
Historic Disasters in Hwashan Creek(Yunlin-DF002)

Serious landslides occurred in upstream areas and resulted in a lot of loose materials accumulated in Hwashan creek.

Small-scale debris flow occurred in Hwashan creek and damaged several houses and roads along the river.

Large-scale debris flow occurred in Hwashan creek again.

About 60,000 m³ sediments flushed to the downstream areas and buried tens of houses and roads.

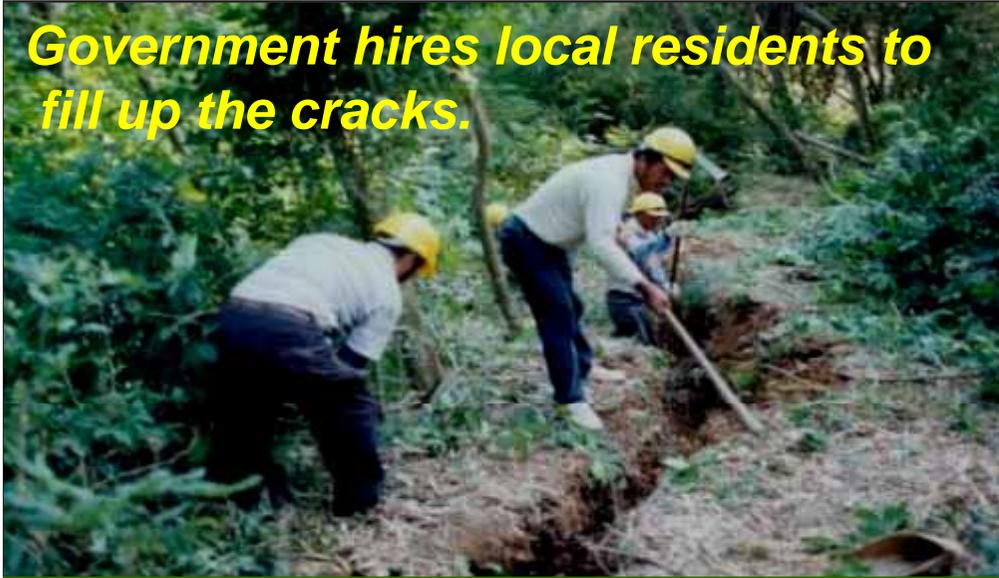
Source treatment in upstream landslide areas

Government hires local residents to fill up the cracks.

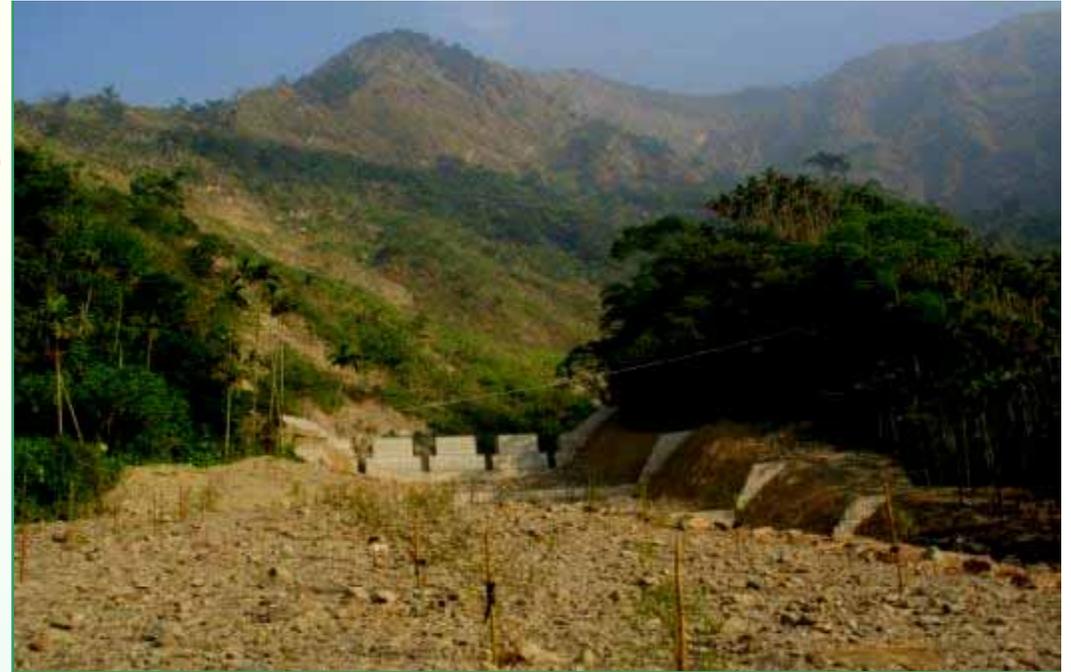
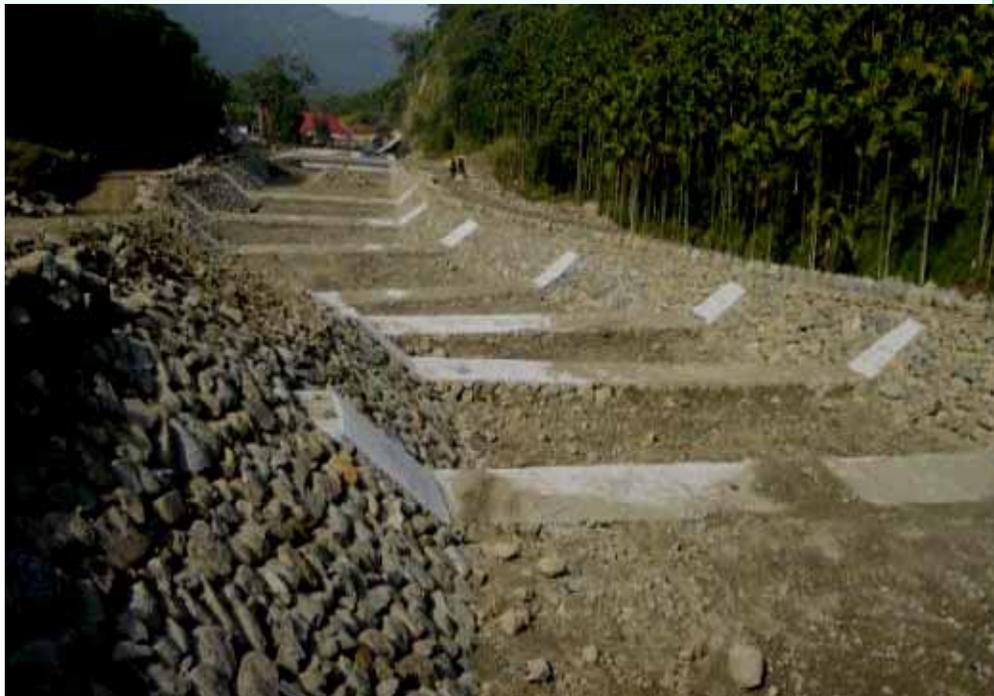
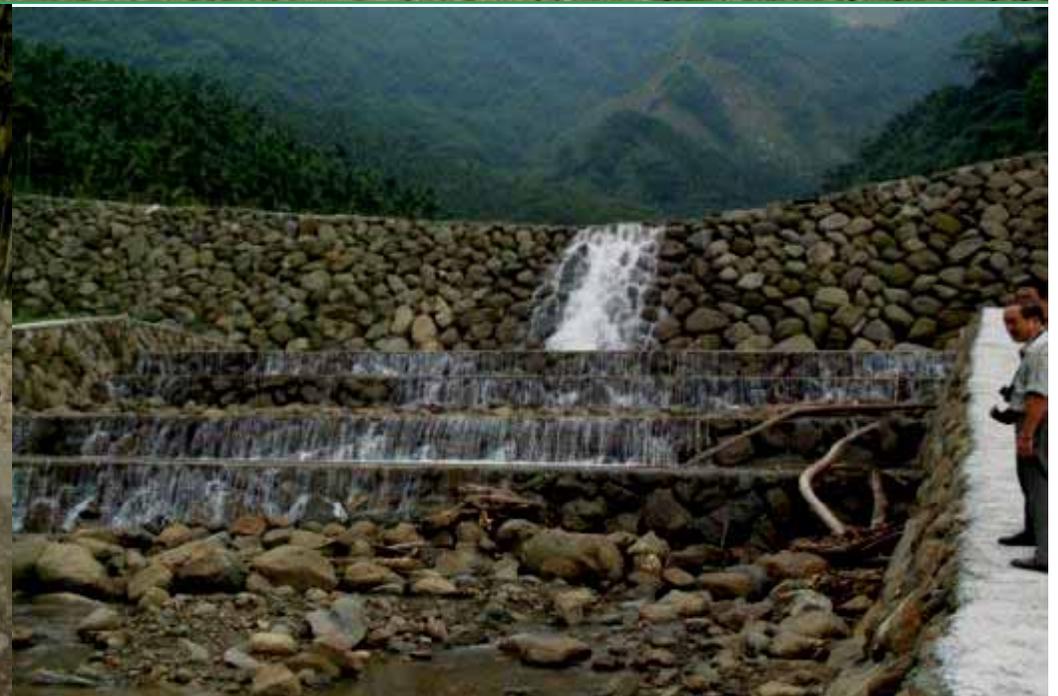
Channel dredging and cleanout

To prevent the blockage of the creek from overflow

Serial check dams

To adjust channel gradient as well we to slow down the water and debris flow velocity for erosion reduction

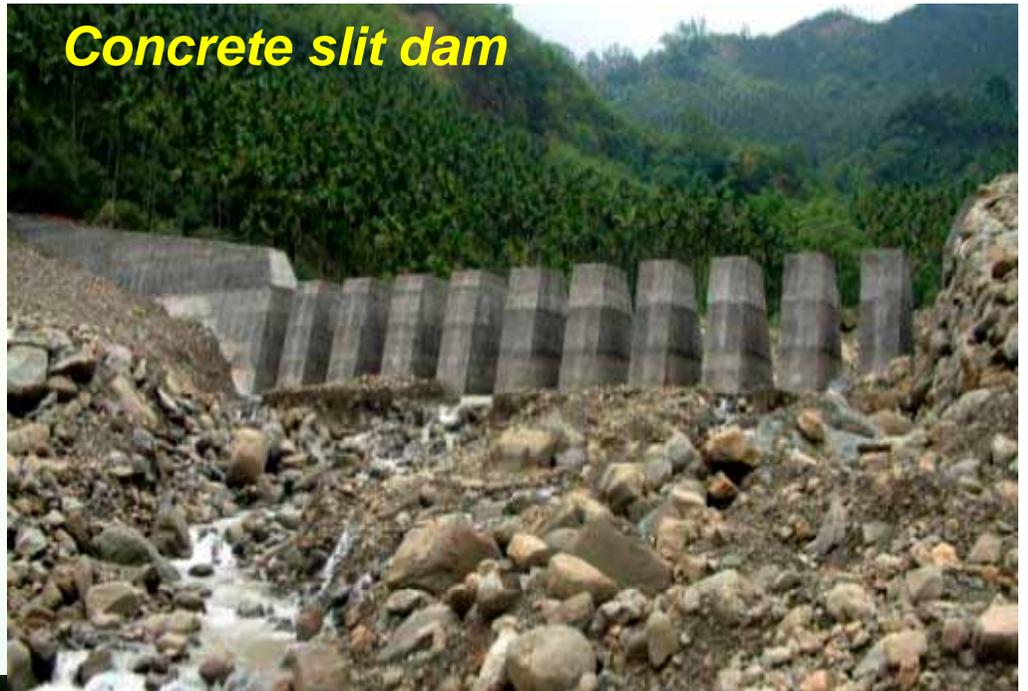
Concrete slit dam

Slit dam(permeable & open type)

The purpose of slit dam is to block big boulders. Small sediments can pass by the dam in order to maintain the normal sediments transportation.

Used tire

Take advantage of used tires to protect the upstream side of the dams

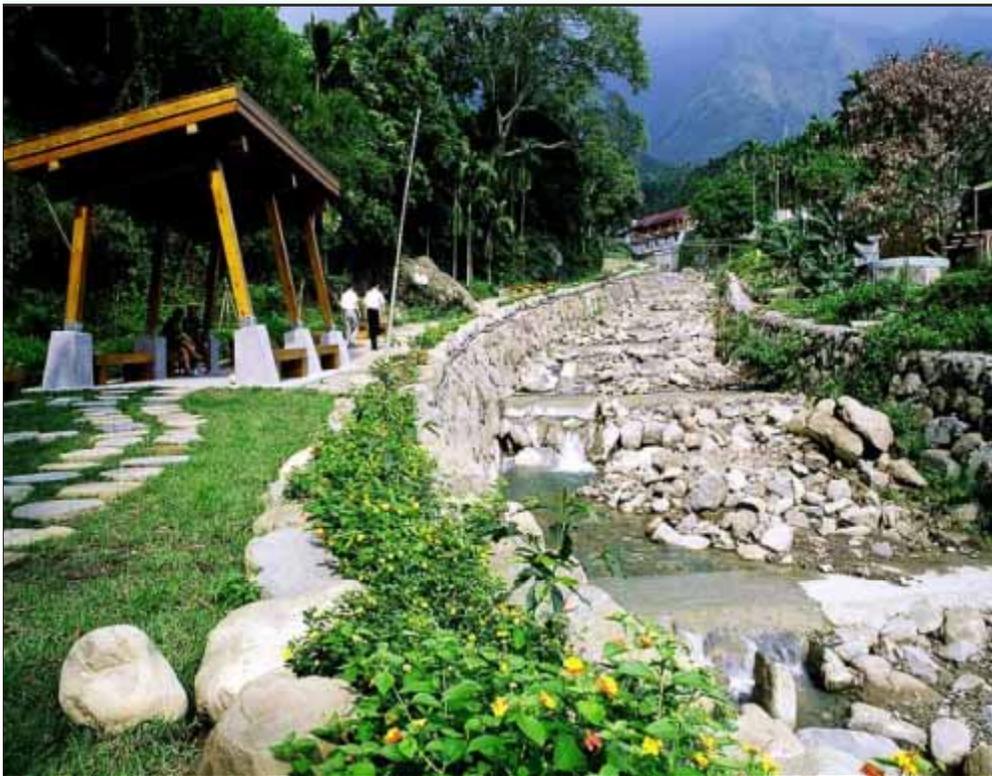
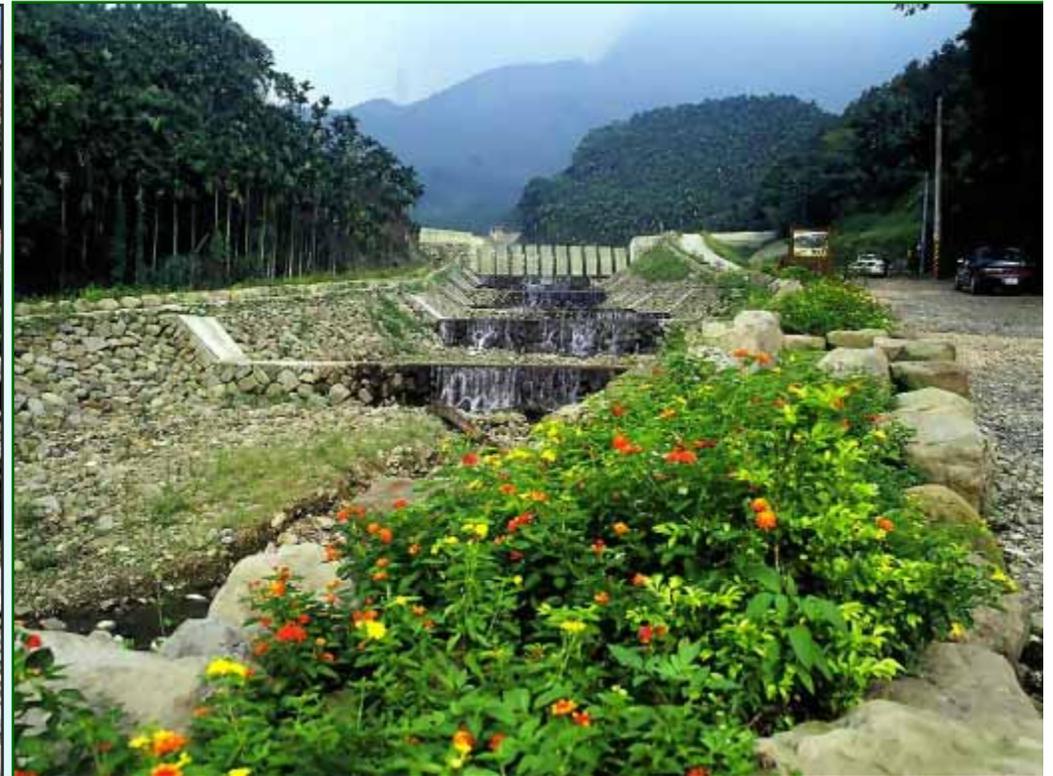
Eco-friendly Design

Use the debris flow materials to build rockery bank revetment to reduce the concrete amount economically.

Mild slope, rough and porous surface design of the bank revetments in order to enrich the biological diversity .

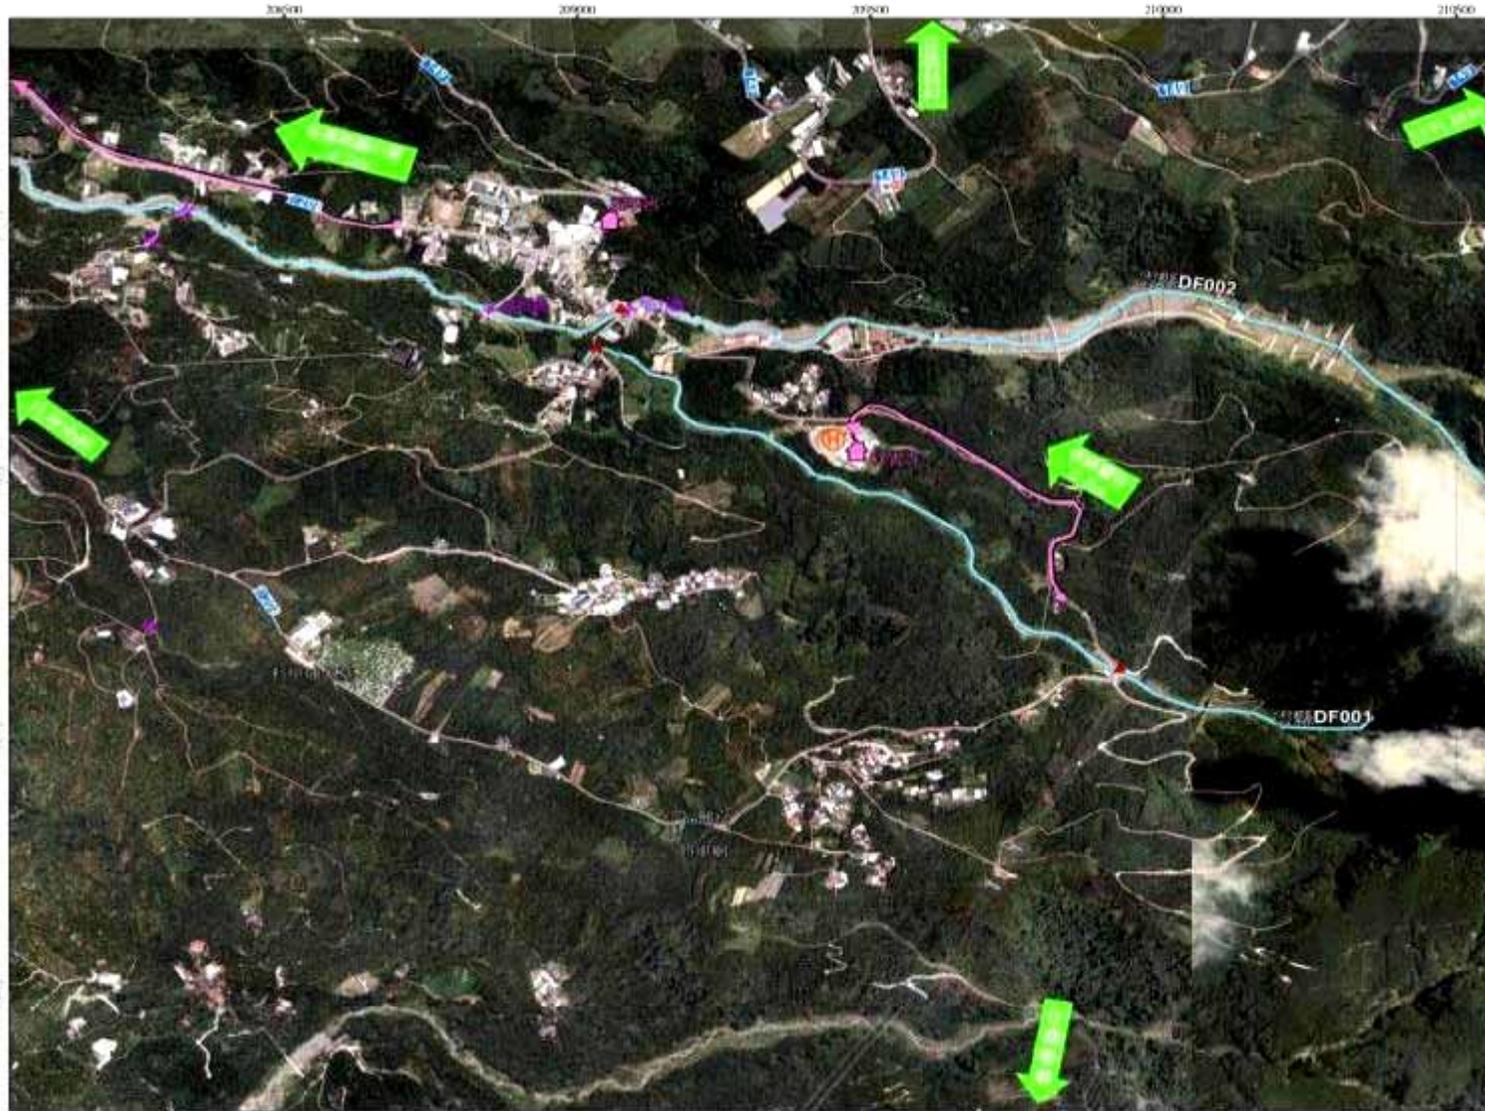
雲林縣古坑鄉華山村土石流疏散避難圖

土石流警戒基準值: 350 mm
土石流歷史災害: 民國89年
二月豪雨、民國89年六月豪

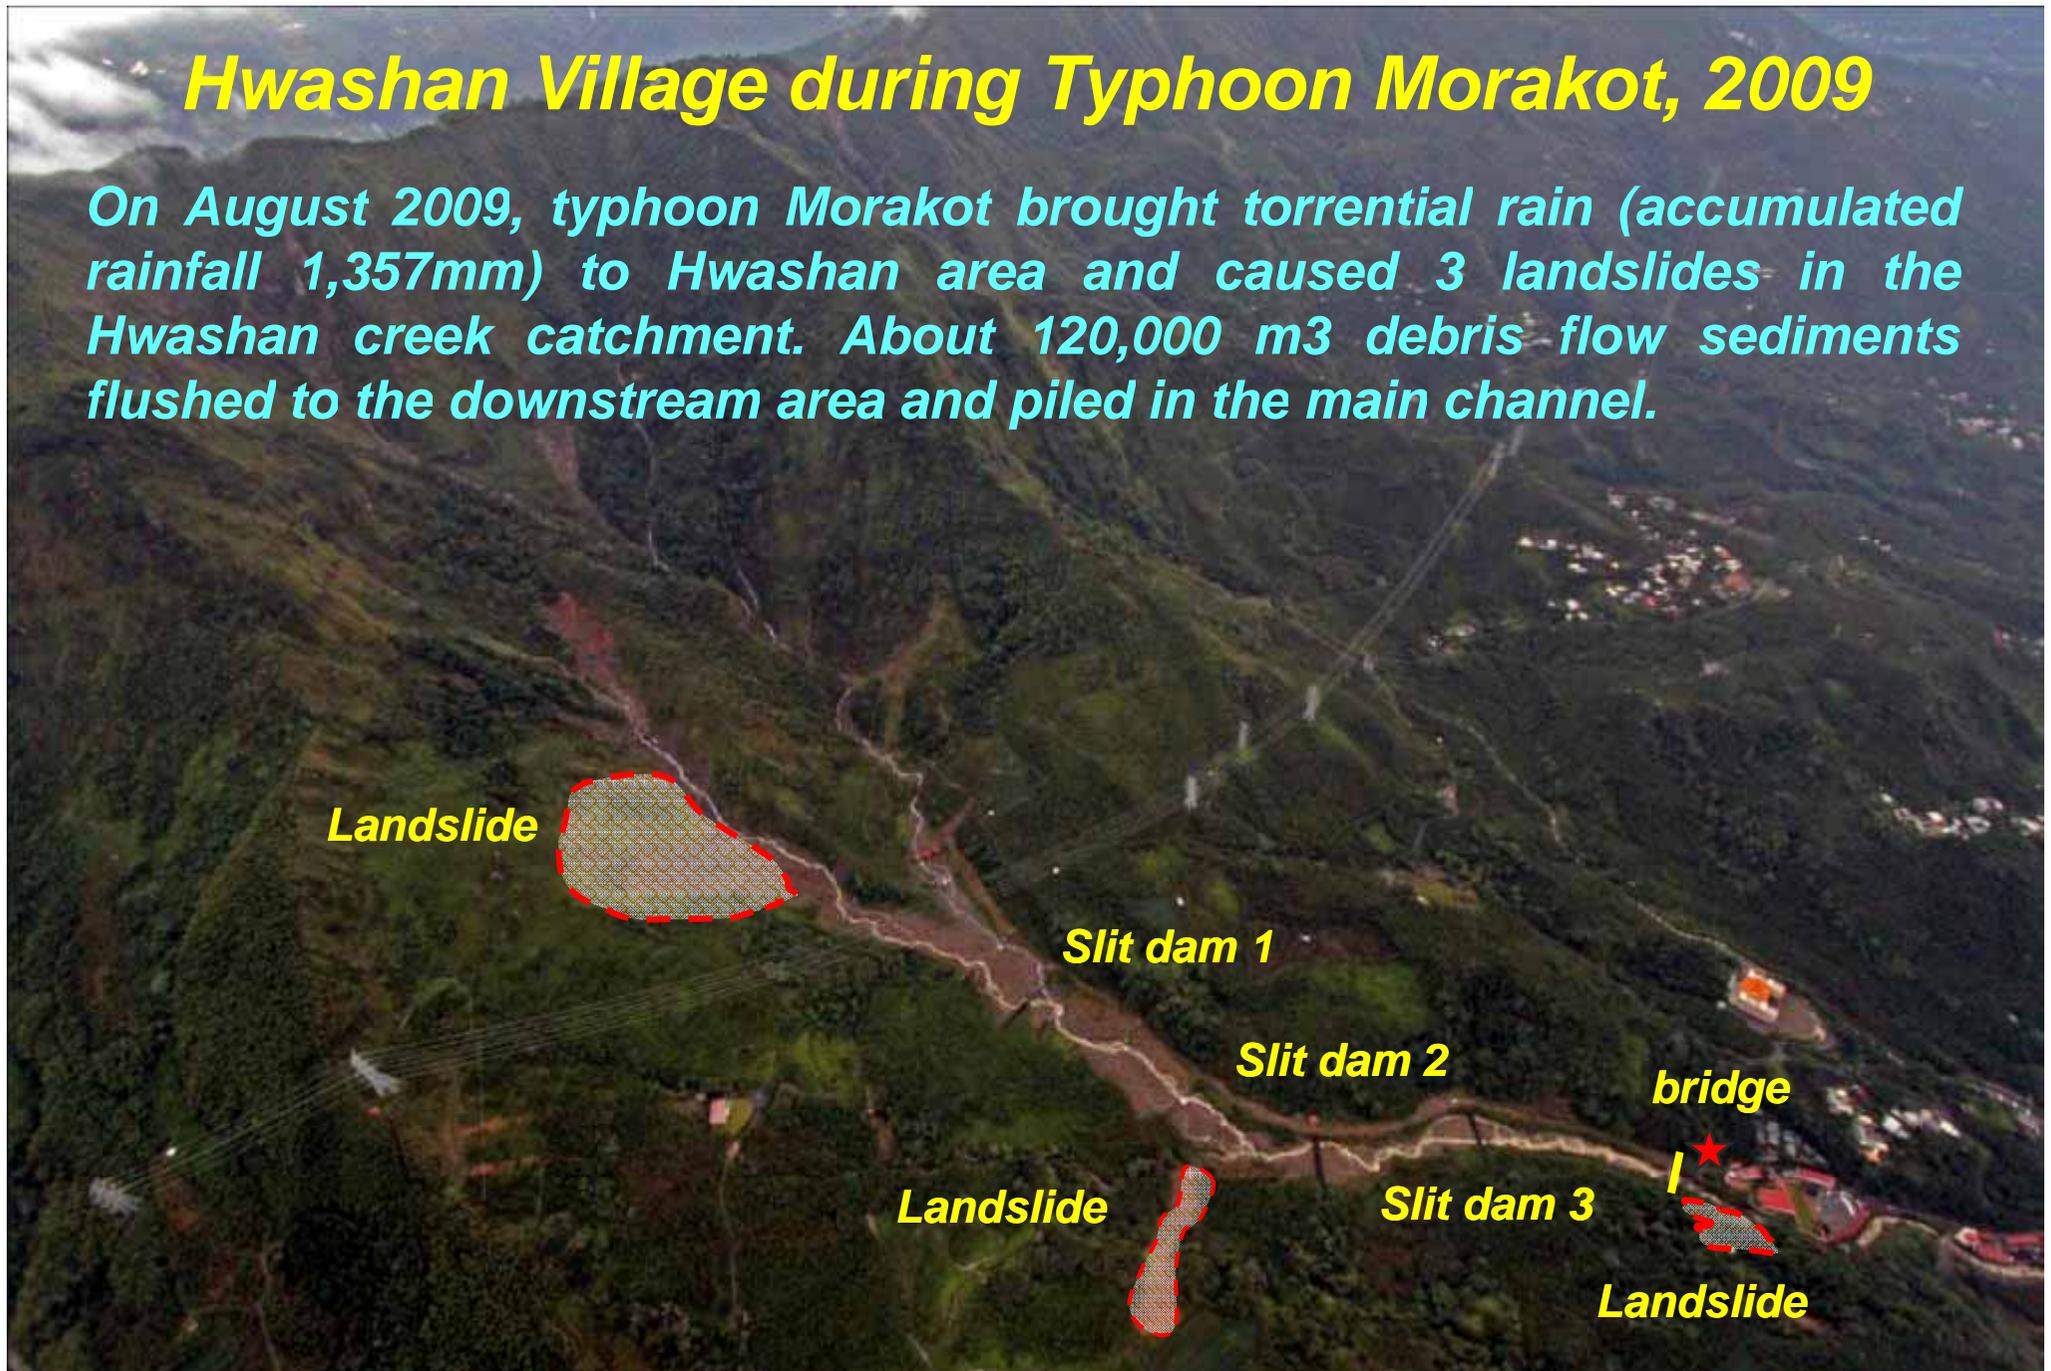
Hwashan Village during Typhoon Morakot, 2009

On August 2009, typhoon Morakot brought torrential rain (accumulated rainfall 1,357mm) to Hwashan area and caused 3 landslides in the Hwashan creek catchment. About 120,000 m³ debris flow sediments flushed to the downstream area and piled in the main channel.

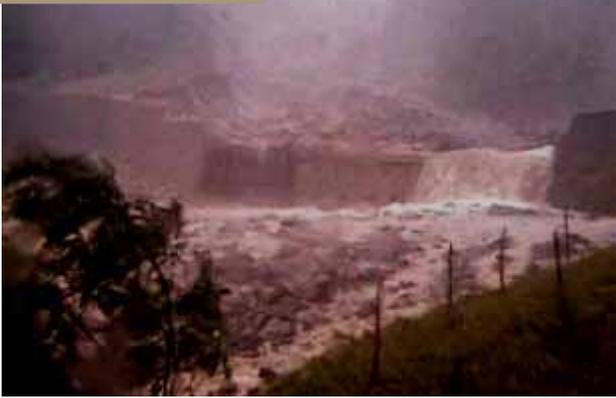
7:30 Aug. 9

Upstream CCD camera

Accumulated rainfall : 1357mm
Peak rainfall intensity : 62.5mm
Wires broke time
 1) 5:23, Aug. 9
 2) 5:23, Aug. 9
 3) 00:48 Aug. 9

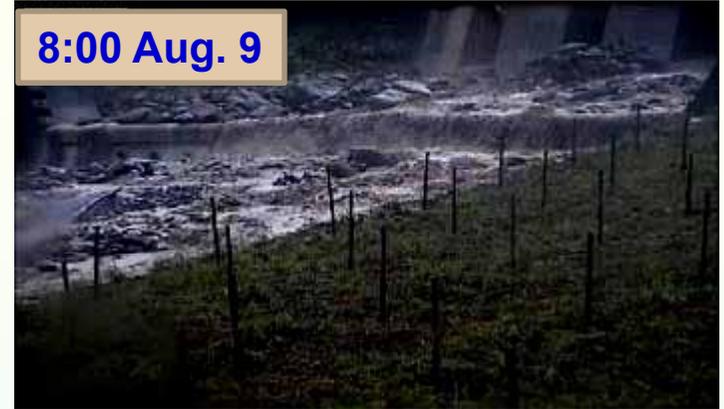
8:00 Aug. 9

Midstream CCD camera
