**2012 International Training Workshop for  
Natural Disaster Reduction**

## ***Early Warning System and On-site Observation of Debris Flow Disasters***

***Hsiao-Yuan(Samuel) Yin Ph.D.***

**Section Chief  
Soil and Water Conservation Bureau  
Council of Agriculture**

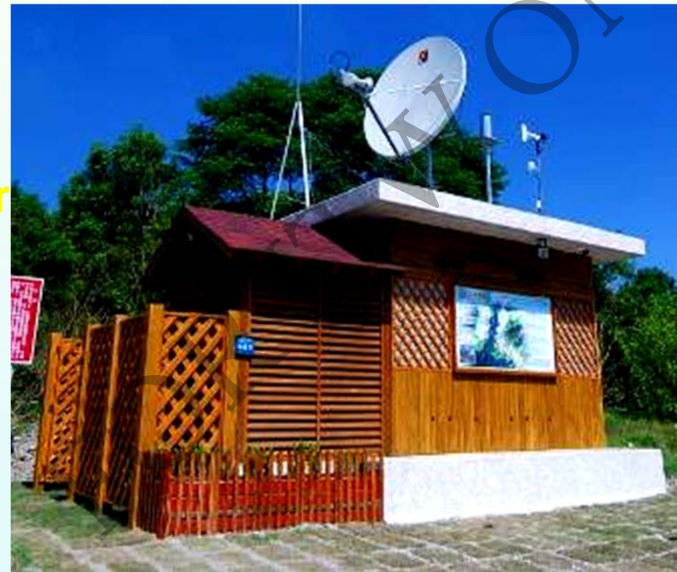
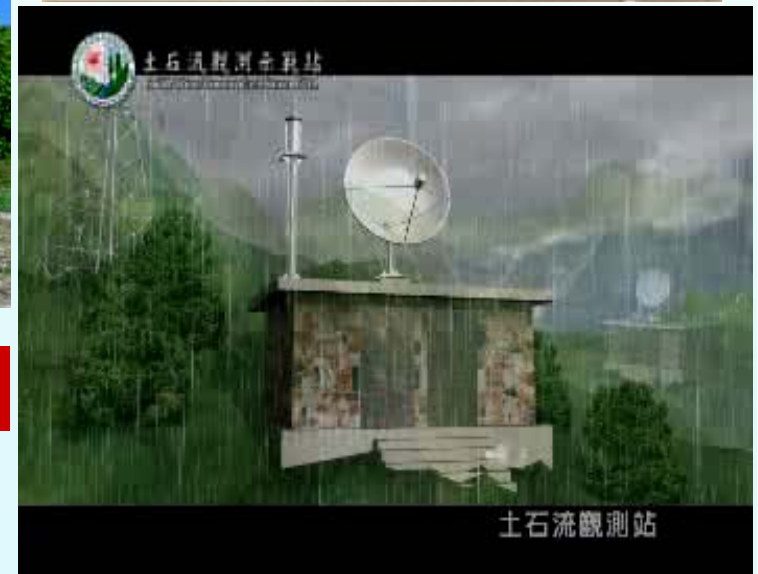
# 17 On-site (fixed) debris flow monitoring station

## Monitoring Sensors

Rain gauge

CCD camera  
Spotlight

Ultrasonic water level meter

Wire sensor

Geophone

## Satellite Transmission

## Instrumental cabin

Data-processing

Power-Supply

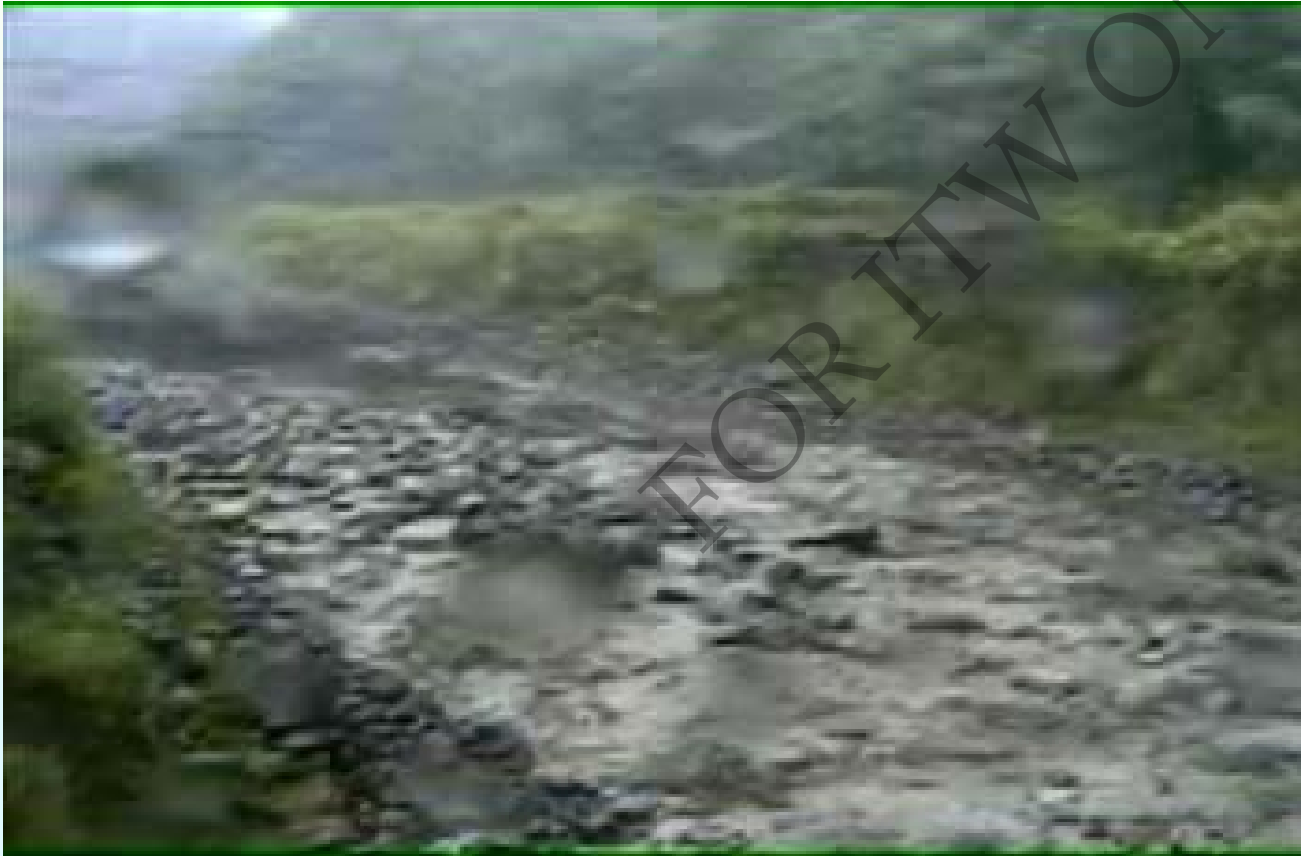
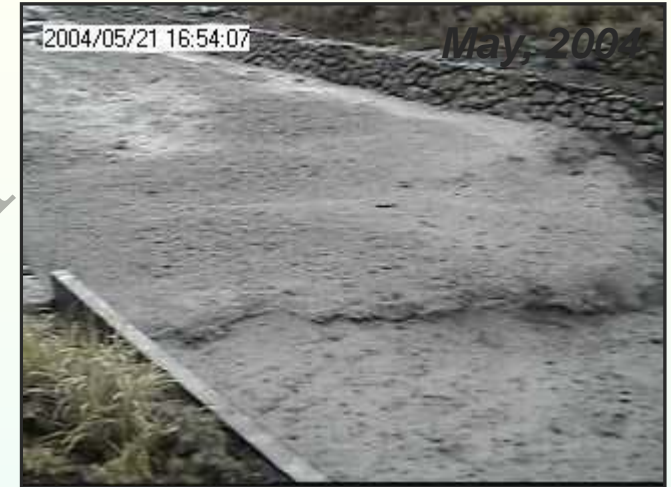
## Characteristics of debris flows from image data

1. A very low discharge just before the surge
2. Accumulation of large boulders at debris flow front
3. Wavy surface of debris flows
4. A rapid decrease of the flow depth behind the front

- the average velocity of front surge 13 m/sec
- the flow depth of the front surge between 5.5 to 6 m
- maximum particle size about 4 to 5 m
- the average flow depth of 2 m
- flow duration of about 5 minutes

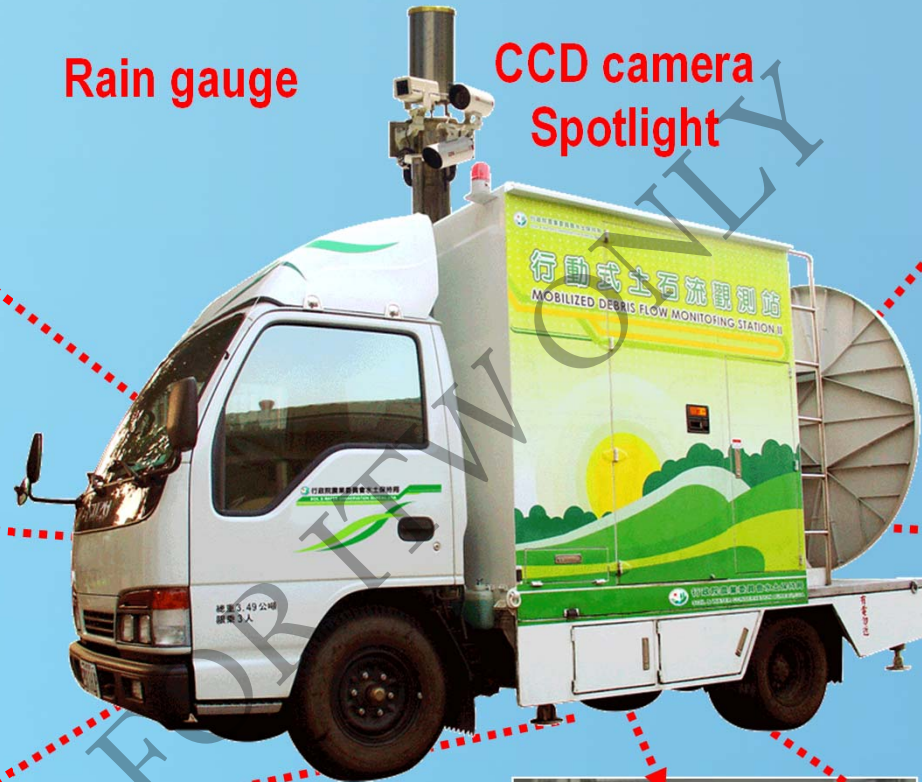
### 3 Mobile debris flow monitoring station (since 2004)

Generator

Inverter

Battery sets

Geophone

Rain gauge

CCD camera  
Spotlight

IPC

GPS

LCD

Spectrum analyzer

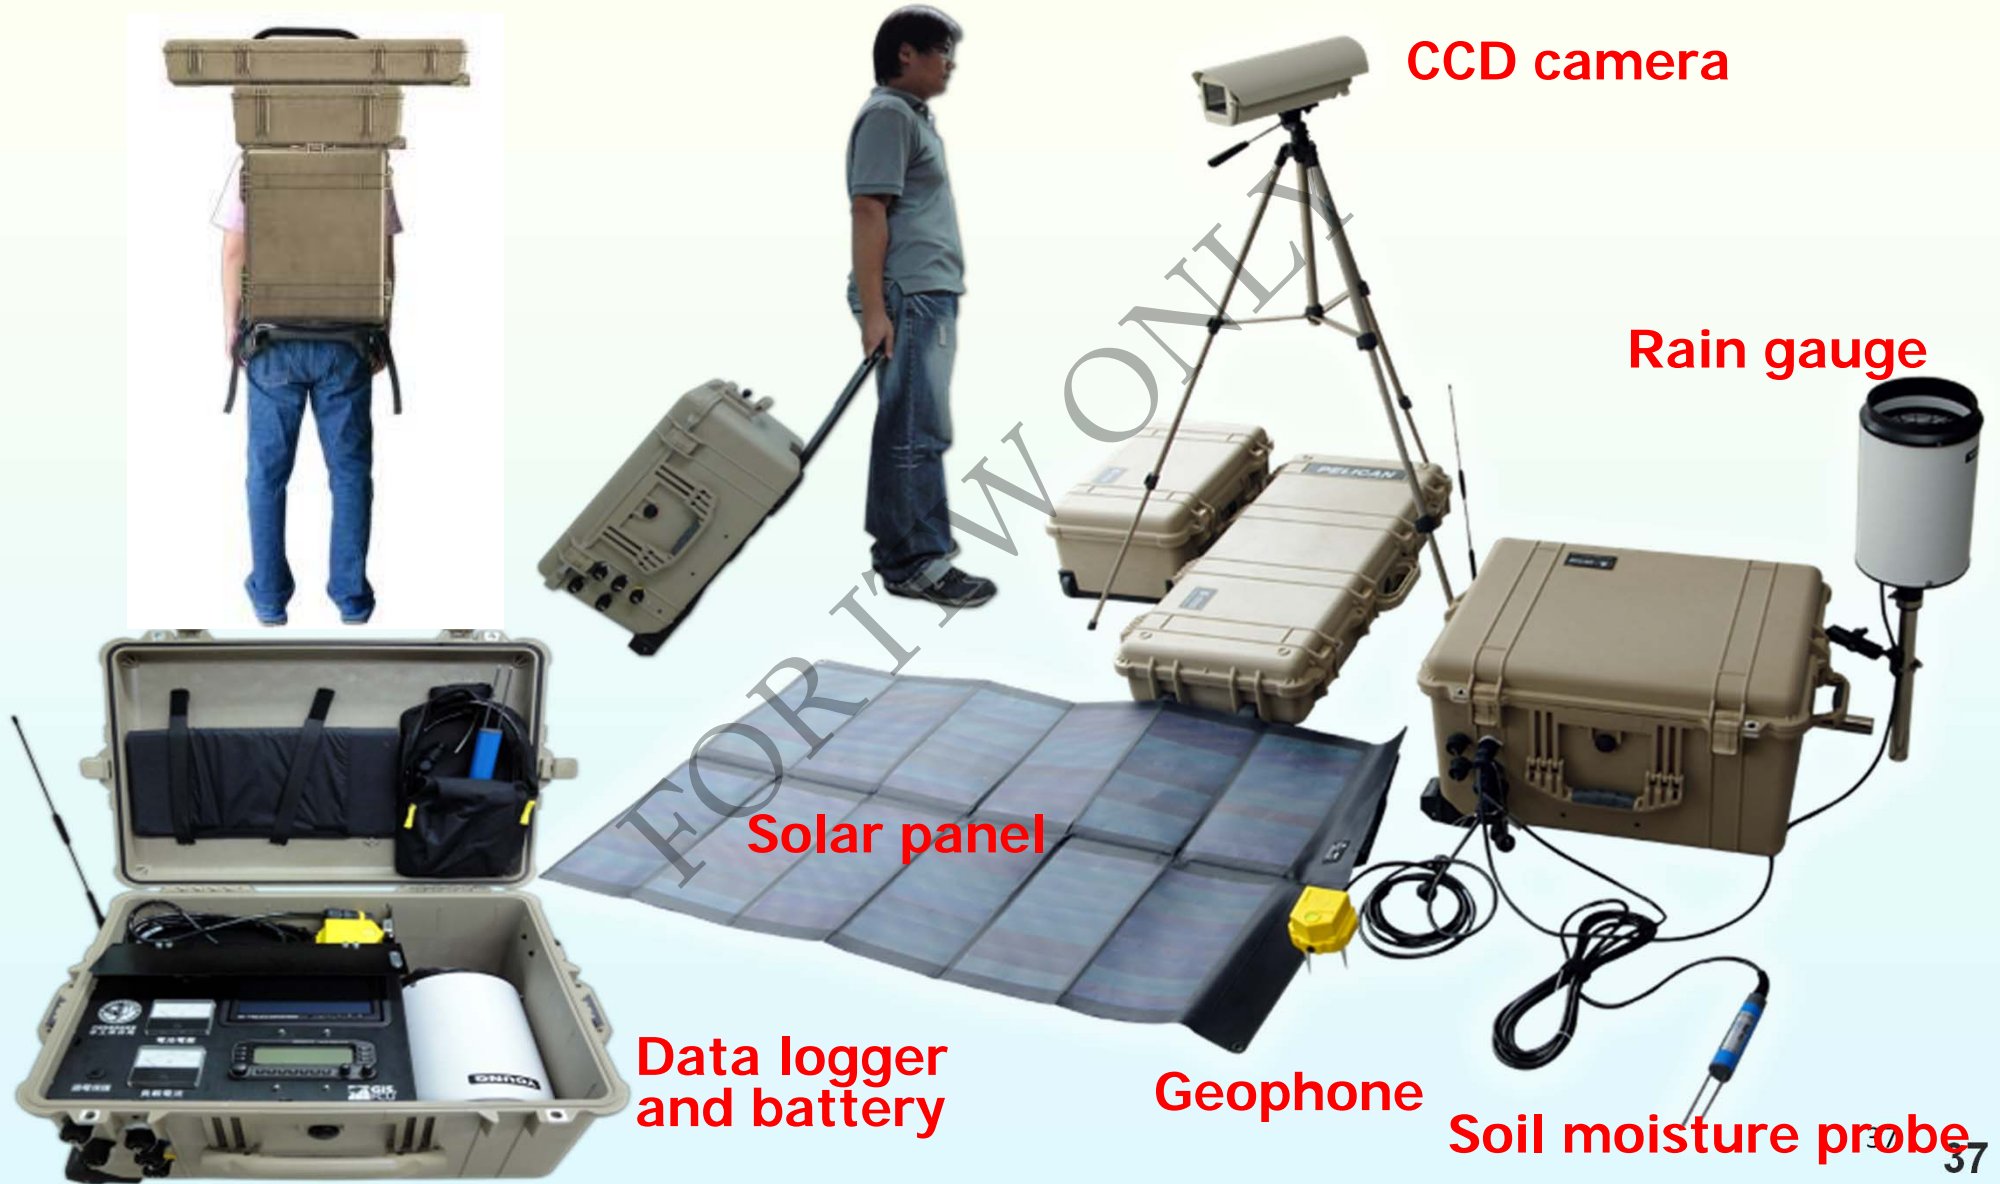
## 14 Grid debris flow monitoring station (since 2010)
